## PROPERTY REPORT

**Property Name:** 19 Prospect Street  
**Address:** 19 Prospect ST  
**Ownership:** Private  
**Apartment #:**  
**ZIP:** 08512

**Survey Name:** Cranbury CLG Survey 2017

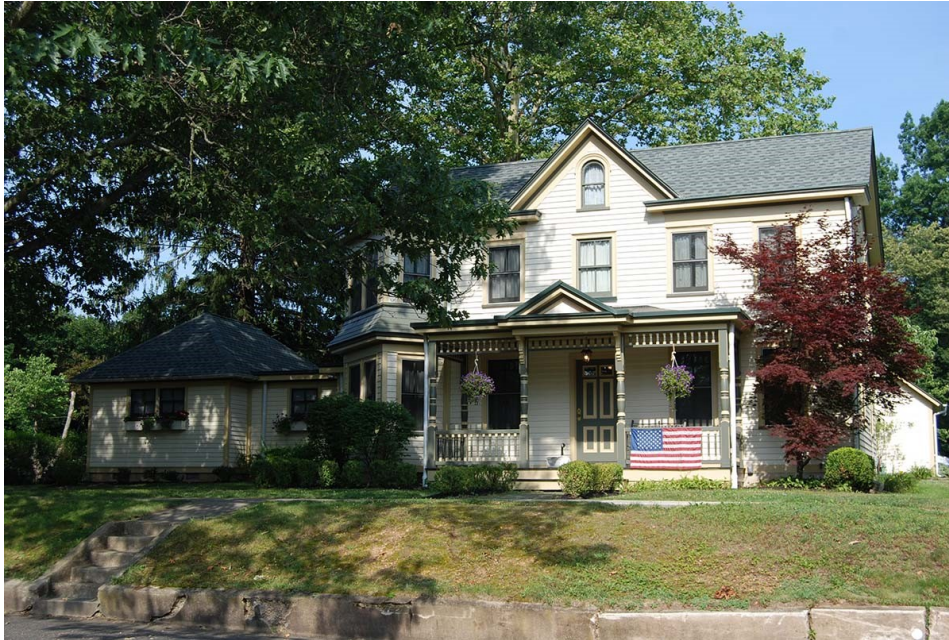
### Property Photo:

19 Prospect Street is a two-and-a-half-story, five-bay, two-pile vernacular Gothic Revival style residence with Queen Anne detailing constructed circa 1880. The house consists of the farmhouse core with an angled corner bay to the southeast, a rear tee section, and a two-part wing extending to the south. The house has asphalt shingles on its cross-gabled roof, which features an asymmetrical gable and cornice returns at the corners of the east elevation. The centered cross-gable on the main (east) elevation contains a one over-one arched headed window with wood sashes (possibly original). An exterior brick chimney is located on the northwest (rear) elevation. The molded cornice doubles as an interior gutter system. The exterior of the dwelling is clad in wood clapboard siding. Fenestration consists of two-over-two, double-hung, wood-sash with aluminum screen windows. The corner bay projects from the southeast corner; it features narrow, paired windows on its main panel and two-over-two windows on the side panels. The entrance consists of a two-light, six-panel wood door within a molded wood surround. The front porch is the most stylish element of the exterior. It features a hipped roof with a projecting centered gable, a spindlework frieze, and four turned posts connected by a railing with turned balusters. Two frame steps lead down to the grade of the front lawn. The north elevation has the same cladding as found on the main elevation (clapboards). Fenestration is irregular. The attic level has two quarter-circle windows below the peak of the offset gable. Windows on this elevation are replacement one-over-one units with vinyl sashes, with two on the second floor and one on the first. An ancillary exit is located near the northwest corner. The west (rear) elevation is the location of a centered one-story ell addition with a gabled roof. Materials on the addition include asphalt shingles on the roof and clapboard walls. It has two bays of windows on the sides and rear. The rear elevation of the main block has one bay of
