PROPERTY REPORT

Property Name: 57 South Main Street
Address: 57 S MAIN ST

Survey Name: Cranbury Local Historic District Survey 2018

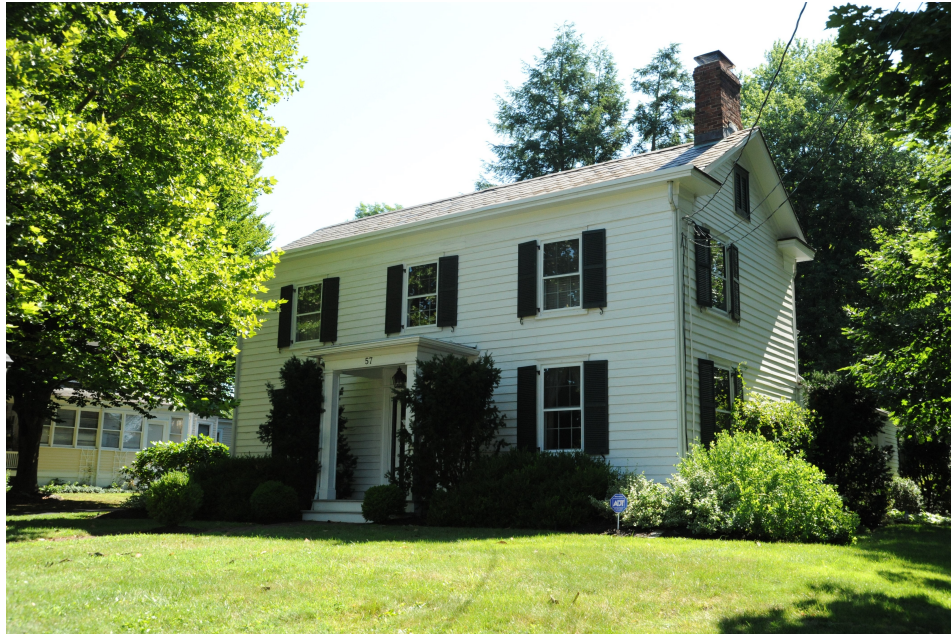
Property Photo:

The 2-story, side gable-roofed, T-plan main block of this clapboard-clad residence on a parged foundation is 3 bays wide and 2 bays deep and is fronted on the west by a 1-story, 1-bay, centered porch and backed on the east by a 2-story, partial-width volume that is in turn flanked on the southwest by a 1-story, partially enclosed porch that wraps around the east elevation. A 2-story, gable-roofed side volume projects from the northeast corner of the main block. The roofs are predominantly clad in asphalt shingle. An interior, brick, ridge chimney is located near the south end of the main block. The windows predominantly have 6/6, double-hung, historic wood sash with historic louvered shutters. The front porch includes replaced square-plan posts with recessed panels. The primary entrance, accessed by the porch, includes a historic, 9-light storm door and a historic paneled door. The historic door surround includes narrow, single-light sidelights a narrow, single-light transom. The remaining bays of both floors are regularly fenestrated. The south, side elevation is only partially visible from the public right-of-way and is lighted in the main block by 2 windows and in the rear volume by 2 6-light casement windows on the first floor and 2 windows on the second floor. The east bay of the porch is enclosed with clapboard siding. The north, side elevation is regularly fenestrated except for a single window on the second floor of the main block. A shuttered window opening is on the third floor of both side elevations. The east, rear elevation is not visible from the public right-of-way. The 1 1/2-story, frame, gable-roofed garage is only

partially visible from the public right-of-way and is clad in wood shingle.

57 S. Main Street is a contributing property to the Cranbury Historic District because it retains integrity and historic, character-defining features such as the historic massing and fenestration patterns of its main volume, historic windows, historic shutters, historic wood door, and historic brick chimney.
