PROPERTY REPORT

Property Name: 55 South Main Street **Ownership:** Private
Address: 55 S MAIN ST **Apartment #:** **ZIP:** 08512

Survey Name: Cranbury Local Historic District Survey 2018

Organization: Paulus, Sokolowski & Sartor

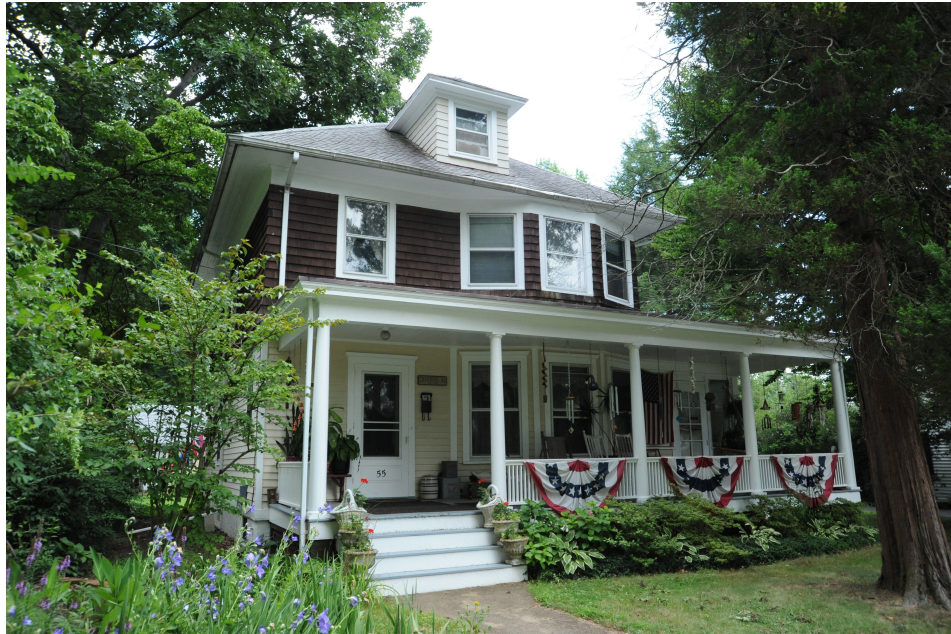
Property Photo:

The 2 1/2-story, hip-roofed, foursquare main block of this clapboard and wood shingle-clad frame residence on a painted brick foundation is 2 bays wide and 2 bays deep and is fronted on the northwest by a hip-roofed porch that wrap around the northwest bay of the southwest, side elevation, where it is enclosed with historic sash above a historic knee wall. 2-story, 3-sided projecting bays are located in the southeast bay of the southwest elevation and the southwest bay of the northwest elevation. A hip-roofed dormer lights each the northwest, southwest, and northeast roof slopes. The roofs are clad throughout in asphalt shingle and the windows predominantly have 1/1 historic sash. The first floor is clad in clapboard and the second floor is clad in wood shingle, with a slightly projecting skirt roof dividing the 2 floors. The sidewalls of the dormers are clad in clapboard and each dormer is lighted by a 1/1 window. The front porch, accessed by a stair in the northeast bay, includes historic Doric columns and a historic rail with square-plan balusters. The primary entrance, located in the northeast bay of the northwest elevation, includes a historic door with a large single light. The remaining projecting bay and second floor bays are regularly fenestrated. The enclosed side porch is accessed from the porch by a historic 8-light door and lighted by 1/1 windows. The southwest, side elevation is regularly fenestrated and includes a secondary entrance to the enclosed porch accessed by a straight stair in the southeast bay. The northeast, side elevation is only partially visible from the public right-of-way and is irregularly

fenestrated. The southeast, rear elevation and the garage are not visible from the public right-of-way.

The residence at 55 S. Main Street is a contributing property in the Cranbury Historic District because it retains its historic massing and fenestration patterns, historic wood window sash, historic porch columns and rail, historic porch enclosure, historic doors, and historic surface materials.
