# PROPERTY REPORT

**Property Name:** 53 South Main Street **Ownership:** Private  
**Address:** 53 S MAIN ST **Apartment #:** **ZIP:** 08512

**Survey Name:** Cranbury Local Historic District Survey 2018

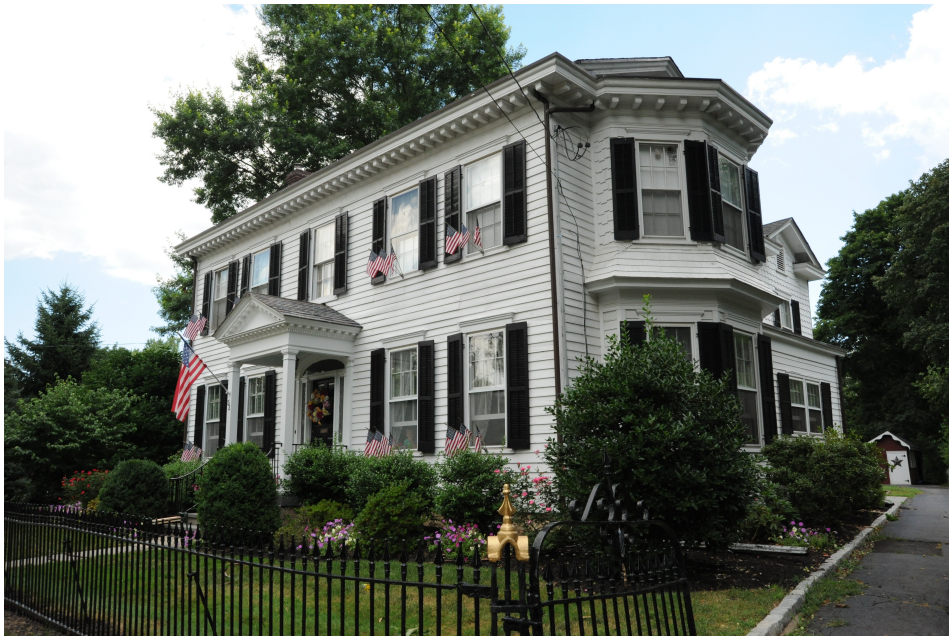
**Property Photo:**

The 2-story, side gable-roofed, rectangular-plan main block of this clapboard-clad, frame residence on a brick foundation is 5 bays wide and 2 bays deep and is fronted on the northwest by a 1-story, 1-bay, pedimented, central porch and backed on the southeast by a 2-story, gable-roofed, L-plan volume that is in turned flanked on the southwest by a 1-story, composite-roofed volume. A 2-story, hip-roofed, 3-sided bay projects from the southwest elevation of the main volume. A 1-story, hip-roofed historic addition is located on the northeast end of the main volume. The roofs of the front porch and main volume are articulated by a dentilled cornices. The roofs are predominantly clad in asphalt shingle except for the front porch and side volume, which are clad in slate tile. An interior, brick, ridge chimney is located near the northeast end of the main block. The windows predominantly have 6/6, historic wood sash with historic louvered shutters. The front porch, accessed by a flared stone and concrete stair with wrought iron rails, includes historic replacement square-plan posts, a simple frieze, and a cornice with both small and large dentils. The primary entrance, located in the central bay of the northwest elevation, includes a historic door surround with leaded glass sidelights over recessed panels and a segmental arch, leaded glass transom. The remaining bays of both floors are regularly fenestrated. The southwest, side elevation is regularly fenestrated. A painted wood shingle-clad pent eave

divides the first and second floors of the southwest bay. The upper floor of the projecting bay and the upper floor of the southeast bay of the rear volume are clad in painted wood shingles of alternating lengths. The northeast, side elevation is lighted on both floors of the main block by a single window and on the front and side elevations of the side volume by 8/8 wood sash windows. The southeast, side elevation is not visible from the public right-of-way. The 2-story, gable-roofed, clapboard-clad barn is located to the east of the residence and includes scalloped bargeboard and historic shuttered openings. The 1-story, asymmetrical gable-roofed, clapboard-clad shed, located to the southeast of the residence, also includes scalloped bargeboards and a historic, simple door.

The residence at 53 S. Main Street contributes to the Cranbury Historic District because it retains integrity and historic, character-defining features such as its historic window sash, historic fenestration patterns, historic clapboard and shingle cladding, historic replacement door, surround and replacement door, and historic wrought iron rail. The barn and shed retain their historic massing, historic openings, and historic surface materials.
