PROPERTY REPORT

Property Name: 40 Station Road **Ownership:** Private
Address: 40 Station RD **Apartment #:** **ZIP:** 08512

Survey Name: Cranbury Historic Sites Survey Phase III

Survey Name: Cranbury Local Historic District Survey 2018

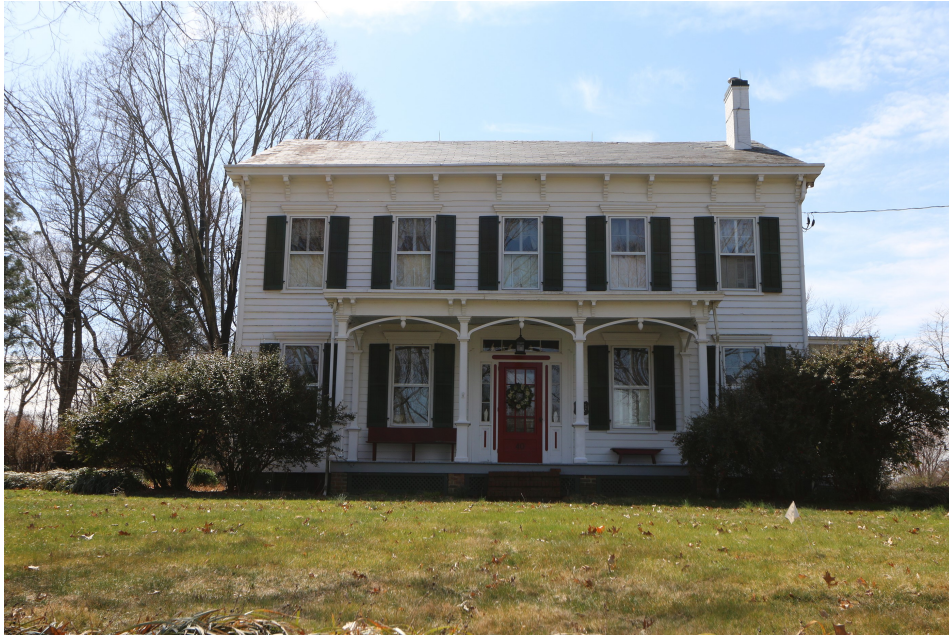
Property Photo:

40 Station Road has undergone little to no alterations since it was surveyed by PS&S in 2018. Similarly, the two outbuildings to the rear (south) of the dwelling do not appear to have changed since 2018.

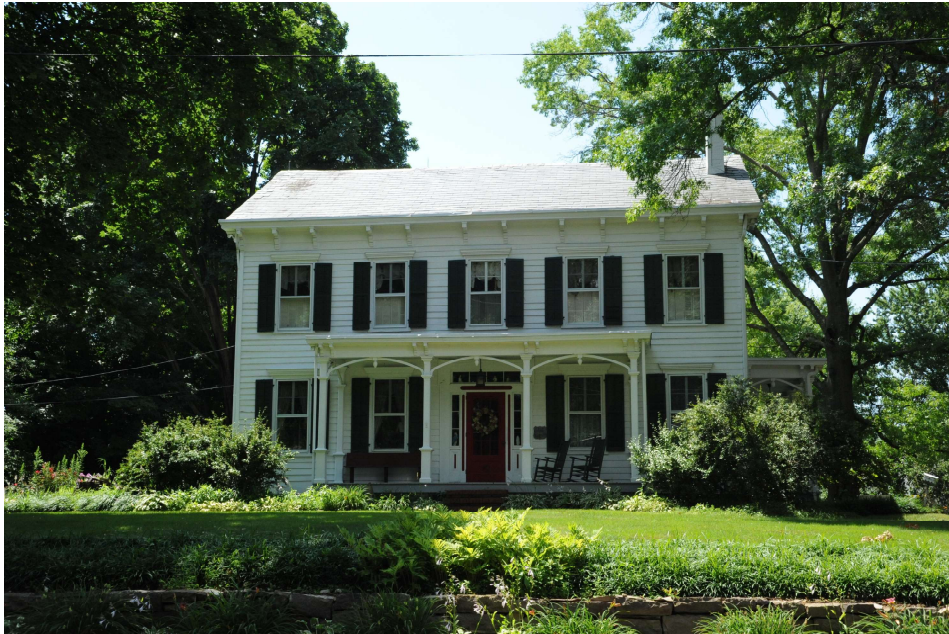
Property Photo:

The 2 1/2-story, rectangular-plan, side-gabled block of this Italianate style, frame, painted clapboard-clad dwelling is 5 bays wide and 3 bays deep and is fronted on the north by a partial-width, centered, 3-bay, flat-roofed front porch and backed on the south by a partial-width, 2 bay-deep, secondary volume that is flanked on both sides by 1-story, shed-roofed porches. The western porch has been enclosed. The main volume is flanked on the west by a centered, 3-bay, 1-story porch with details matching the front porch. These porches include square-plan, chamfered posts on plinths rising to a cornice that serve as the springing point for basket-handle arches between the posts with central pendills in the arches. A painted brick, interior slope chimney is located on the north side of the main roof near the western end of the main block and a second painted brick chimney is located on the south end of the ridge of the secondary volume. The main visible roofs are clad in slate shingle. The windows throughout on the main volumes first and second floor retain historic, 4/1, double-hung wood sash with heavier vertical muntins in the upper sash. Paired, round-arch windows with 4/4 sash articulate the gable ends of the main volume on the third floor. The windows also retain historic, louvered wood shutters. The main roofline and the roofline on the main volume porches include paired scroll brackets. Cornice returns are found on the gable ends of the main volume. The main entrance, centered on the north elevation, is accessed via brick stairs fronting the porch, and includes a historic door surround with 3-

light sidelights above recessed panels and a 4-light transom. The door is not visible from the public right-of-way but is fronted by a historic, wood, multi-light storm door. The eastern, side elevation, only partially visible from the public right-of-way, includes multi-light sash in the enclosed porch and a historic 6/6 window on the second floor of the rear volume. The western, side elevation, only partially visible from the public right-of-way, includes a centered entrance accessed by the porch. The entrance includes a historic surround with a single-light transom flanked by a small window on its south and a historic door fronted by a historic storm door. A 6/6 window is visible in the second floor of the rear volume. The rear, south elevation is not visible from the public right-of-way.

The 1 1/2-story, painted clapboard-clad, gabled, frame garage is located southwest of the house. Its main, east elevation includes 2 garage bays on the south side and a man door with a historic, paneled wood door flanked by a 6/6 windows. 2 6/6 windows are located on the upper floor on this elevation, which includes a saw-tooth pattern barge board. The garage bays include replaced, roll-up doors. The 1-story, clapboard- and vertical board-clad, frame, gable-roofed, rear secondary building, includes a sliding door and a scalloped barge board on its western elevation.

40 Station Road is a key-contributing property because it retains integrity and historic, character-defining features such as its historic massing and fenestration patterns, historic windows and doors, historic cornice brackets and porches, and historic secondary buildings.
