# PROPERTY REPORT

**Property Name:** Henry Perrine House **Ownership:** Private  
**Address:** 47 S MAIN ST **Apartment #:** **ZIP:** 08512

PS&S recommends that 47 S. Main Street, constructed circa 1796 and extensively renovated circa 2015, is a contributing property in the Cranbury Historic District.

**Survey Name:** Cranbury Local Historic District Survey 2018

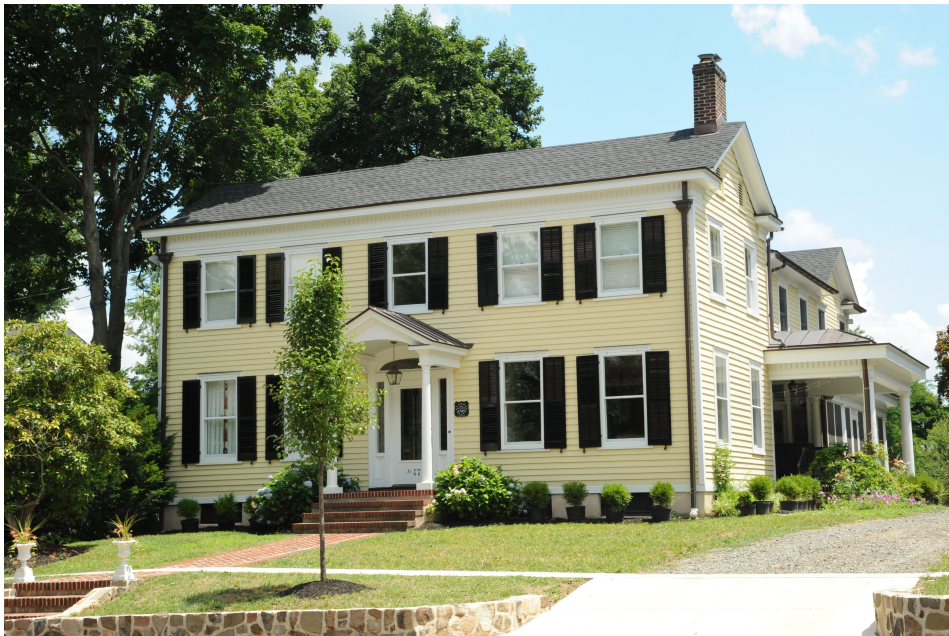
**Property Photo:**

The 2-story, side gable-roofed, rectangular-plan main block of this clapboard-clad, frame residence on a concrete foundation is 5 bays wide and 2 bays deep and is fronted by the elevation by a 1-story, gable-roofed, 1-bay centered entry porch and backed on the southeast by a 2-story, gable-roofed, full-width, 5 bay-deep, altered secondary volume. The rear volume matches the height of the main volume in the northwest bay and projects higher in the 4 southeast bays, with a gabled wall-dormer in the southeasternmost bay. A 1-story, hip-roofed, side porch projects from the northwest bay of the southwest side of the rear volume and extends beyond the southwest elevation of the main block. The remaining bays of the southwest elevation of the rear volume are flanked by a 1-story, shed-roofed, enclosed porch. The roofs are predominantly clad in asphalt shingle except for the porches, which are clad in standing-seam metal. The windows throughout have replacement frames and 1/1 replacement sash. The front porch includes Tuscan columns and a historic segmental arch under the gable that matches the fanlight over the door. An interior, brick, ridge chimney is located near the southwest elevation of the main volume. The historic door surround includes single-light sidelights over recessed panels and a segmental arch, leaded-glass fanlight. The remaining bays are regularly fenestrated on both floors. The southwest, side elevation is regularly fenestrated in both the main and rear volumes. A secondary entrance is accessed by the projecting side porch, with includes replacement columns and an added dentilled

cornice. The enclosed porch, accessed by a door in the central bay, is articulated by columns and lighted by large, single-light windows over recessed panels. The northeast, side and southeast, rear elevations are not visible from the public right-of-way.

47 S. Main Street is a contributing property to the Cranbury Historic District because it retains character-defining historic features such as the historic replacement door surround and historic chimney. However, the scale of volumes added in recent construction campaigns, the altered fenestration patterns, and the near-total replacement of windows and surface materials make this status extremely marginal.
