# PROPERTY REPORT

**Property Name:** 12 Cranbury Neck Road **Ownership:** Private  
**Address:** 12 Cranbury Neck RD **Apartment #:** **ZIP:** 08512

**Survey Name:** Cranbury Historic Sites Survey Phase III

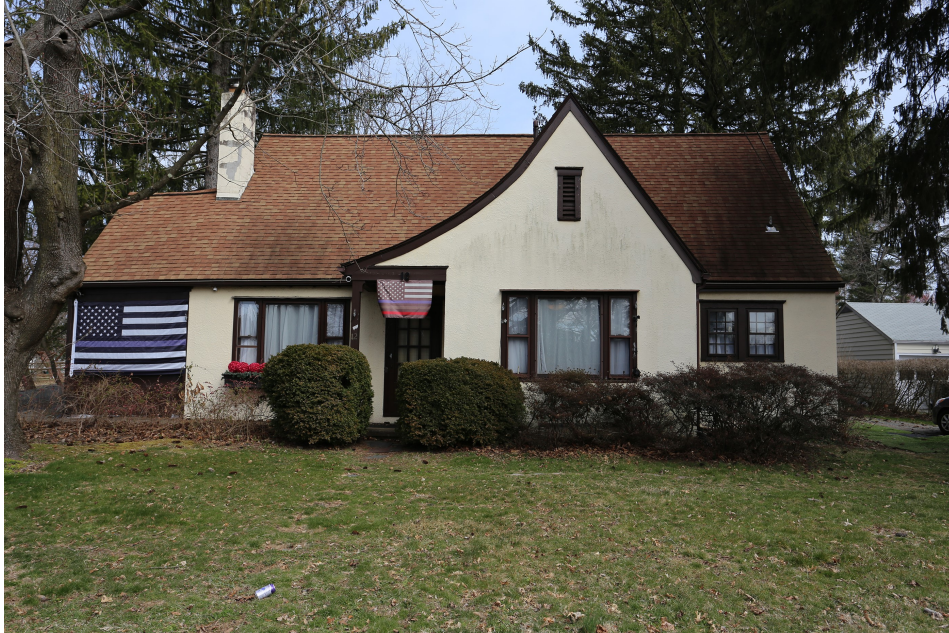
## Property Photo:

12 Cranbury Neck Road is a one-and-one-half-story-tall, four-bay-wide, three-bay-deep, frame dwelling built circa 1933 in the Tudor Revival style. The dwelling consists of a side-gabled main block and an off-center, front-gabled wing with a flared eave that forms a covered porch. Extending from the west elevation is a one-story-tall side-gabled porch. An interior parged chimney rises above the roof junction of the main block and porch. The roof is sheathed in asphalt shingles. The exterior of the dwelling is covered in stucco (historic, likely original). Windows are primarily paired, six-over-six, wood-sash units, set within wood surrounds (historic, likely original) with aluminum storm windows. A tripartite vinyl window is featured in the west bay of the primary elevation of the main block and another is located on the front-gabled wing. The front-gabled wing also contains a wood louvered vent in the gable end. Situated in the second westernmost bay of the main block, beneath the porch formed by the flared eave of the front-gabled wing, the primary entrance features a wood French door (possibly historic) and is accessed by a concrete stoop. The east elevation of the main block contains a central, secondary entrance with a wood paneled door and a metal storm door, sheltered by a gabled portico with wood posts. The rear (north) elevation is not visible from the public right of way. The dwelling stands atop a parged foundation.

Character-defining elements of the dwelling include its massing, wood-sash windows, and front-gabled wing with a flared eave.

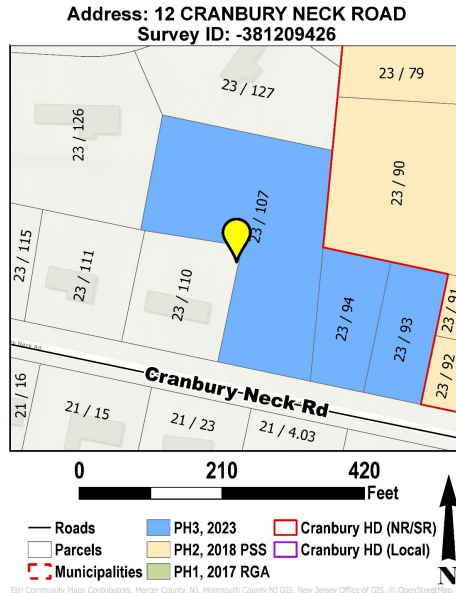
**Site Map:**

12 Cranbury Neck Road is sited on an irregularly shaped parcel (Block 23, Lot 107) located on the north side of Cranbury Neck Road in Cranbury Township, Middlesex County, New Jersey. The dwelling is oriented with its primary elevation facing south and is set back approximately 40 feet from the road. A gravel driveway encircles the dwelling. A concrete sidewalk lines the south border of the property. Mature trees and shrubs are planted within close proximity to the dwelling. The subject property is located in a residential neighborhood surrounded by properties dating from the mid-nineteenth to the early twentieth centuries.
