PROPERTY REPORT

Property Name: 77 North Main Street
Address: 77 N Main ST
Ownership: Private
Apartment #:
ZIP: 08512

Survey Name: Cranbury CLG Survey 2017

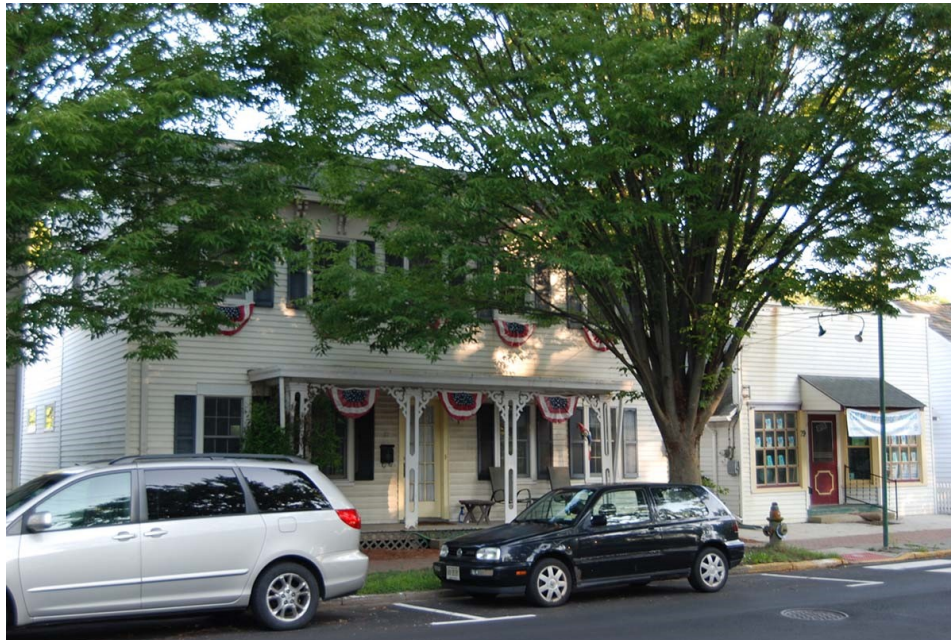
Property Photo:

77 North Main Street is a two-story, five-bay, two-pile, frame private residence constructed circa 1860. The building has a two-story rear ell aligned with its southern gable end wall and a one-story section aligned with its north end wall. The side-gabled roof is sheathed with asphalt shingles and features a molded cornice supported by a course of paired brackets. An exterior brick chimney pierces the roof on the north end. The exterior of the dwelling is clad in wood clapboard siding. Windows (all replacement units) vary from six over-six to six-over-one vinyl-sash flanked by louvered shutters. The second floor has five windows, and the first floor has two on each side of the centered entrance, a French door with multiple inset lights. The front porch covers the center three bays; it has a flat roof supported by thin posts connected with jigsaw spandrels. The house has a stone foundation.

The north elevation repeats the cladding of the main elevation (asphalt shingles on the roof and wood clapboard walls). The brick chimney is a major feature of the elevation. The cornice returns help frame rectangular louvered attic windows. The only wall opening on this end wall is a shuttered first floor window east of the chimney. The south end wall is similar in appearance, with an asphalt-shingled roof, wood clapboard walls, cornice returns, and attic louvers. Character-defining elements of the building include a bracketed cornice and wood frieze.
