PROPERTY REPORT

Property Name: 79 North Main Street
Address: 79 N Main ST
Apartment #:
Ownership: Private
ZIP: 08512

Survey Name: Cranbury CLG Survey 2017

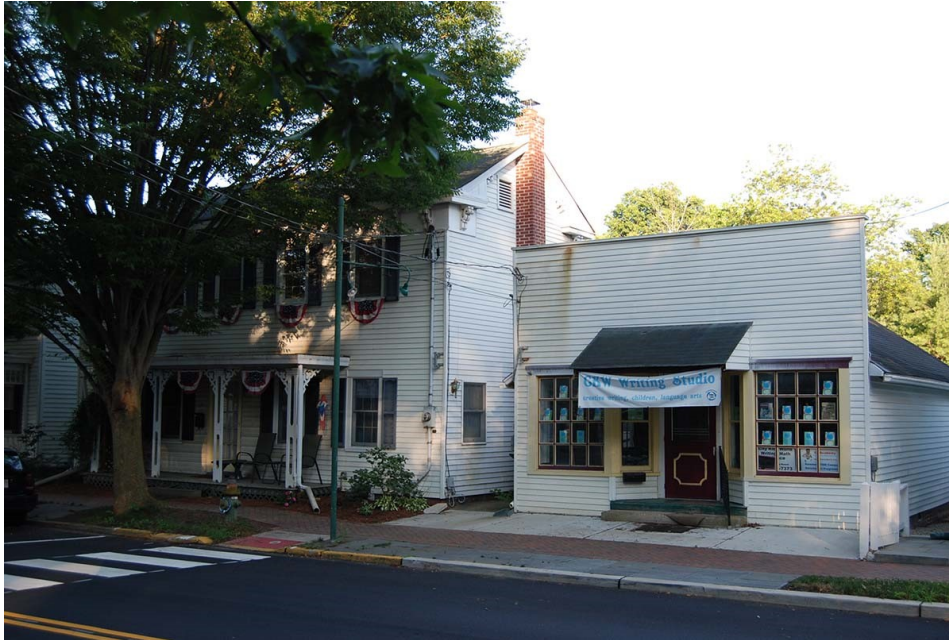
Property Photo:

79 North Main Street is a one-story, three-bay, one-pile, frame commercial building with a storefront obscuring its gabled roof. The front of the building is clad in wood clapboard siding and contains a commercial appearance with a recessed canted entrance between large multi-light display windows. The central entrance consists of a single door with a large pane above a quatrefoil panel. A pent extends above the recessed entrance.

The north and south elevations of the building are identical. The gabled roof is clad with asphalt shingles, and the walls are solid wood clapboard with no windows. The building has a stone foundation.

Character-defining elements of the building include a parapet roof and a canted commercial entrance featuring wood windows with multiple inset lights.
