PROPERTY REPORT

Property Name: 69-71 North Main Street **Ownership:** Private
Address: 69-71 N Main ST **Apartment #:** **ZIP:** 08512

Survey Name: Cranbury CLG Survey 2017

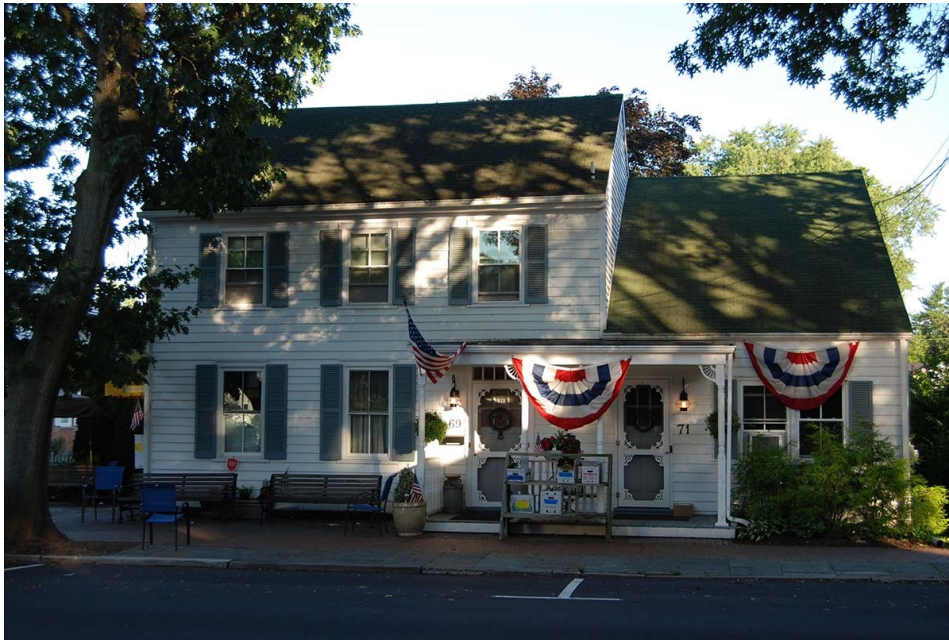
Property Photo:

69-71 North Main Street is a two-part building consisting of a two-story, three-bay, two-pile south section and a one-story, two-bay, three-pile north section, aligned on the main (east) elevation.

The larger south section (69 North Main Street) was constructed circa 1842. Its side gabled roof is sheathed with asphalt shingles and features an attached (exterior) chimney on the south end. The house has a molded cornice but no returns on the end walls. The house's frame walls are clad with wood clapboard siding. Fenestration consists of two-over-two vinyl-sash within molded wood surrounds, flanked by louvered, inoperable shutters. The entrance is located in the north bay of the main elevation, below a front porch that extends along the front of the addition. The door is a paneled unit with six lights above four panels and opens below a four-pane transom. It has a historic screen door that appears to date to the late nineteenth century. The porch is a one-story element with a shed roof supported by four replacement turned columns. The porch floor is one step above the grade of the sidewalk. The house has a stone foundation.

The south end of 69 North Main Street is frame and clad with composite wood shingles. The attached brick chimney is a major element of this elevation. Fenestration is mostly symmetrically arranged, but window details are obscured by large awnings. The attic level has a centered window, and the second floor has two windows; each of these windows features flanking paneled shutters. The first floor has a picture window east of the chimney with undersized paneled shutters.

71 North Main Street is the north section of the building. It has an end-gabled roof with an asymmetrical gable, clad with asphalt shingles. The frame walls are clad with wood clapboards. The entrance is located in the south bay, opening onto the front porch described above. The door is a paneled wood unit with six inset lights over four panels and a historic screen door. North of the door is a paired two-over-two vinyl sash (replacement) window flanked by undersized, louvered shutters.

The north elevation of 71 North Main Street is clad with composite wood shingles. Fenestration is highly asymmetrical. Windows are one-over-one (replacement) units, arranged on two floor levels. The size and shapes of the windows varies widely, with two sets of paired units.
