PROPERTY REPORT

Property Name: 57 North Main Street **Ownership:** Private
Address: 57 N Main ST **Apartment #:** **ZIP:** 08512

Survey Name: Cranbury CLG Survey 2017

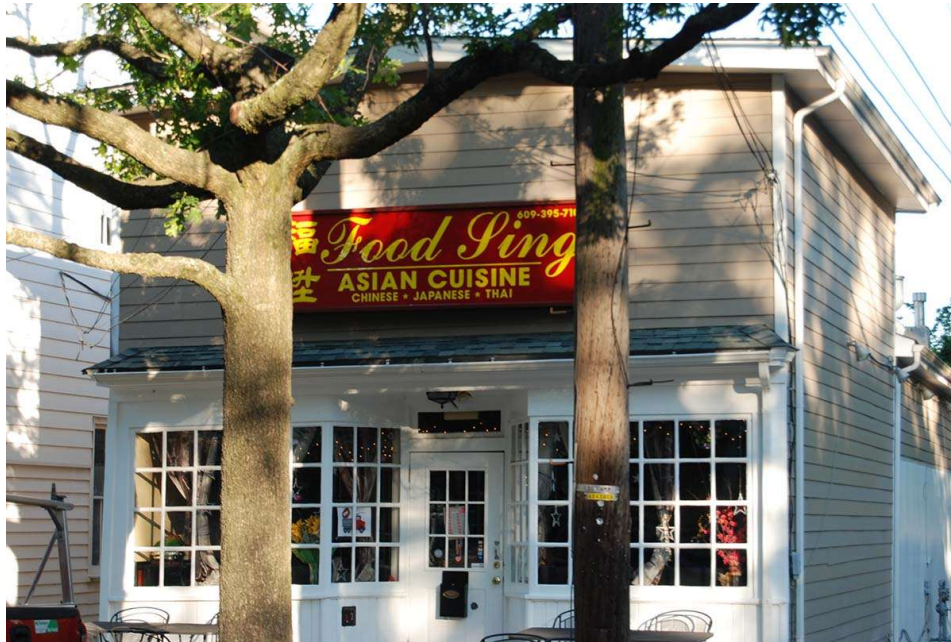
Property Photo:

57 North Main Street is a one-and-a-half-story tall, three-bay wide, two-bay deep, frame commercial building constructed circa 1945. A one-story, three-bay, front-gabled addition extends to the northwest. The front-gabled roof has a very gentle slope; it is sheathed with asphalt shingles and aluminum-clad eaves. An exterior brick chimney pierces the roof on the southwest slope of the main block. The exterior of the building is clad in wood clapboard siding. The second floor has no windows; previous windows were sealed in the late twentieth century. The first floor is sheltered by a pent roof with asphalt shingles. The commercial entrance consists of a central canted door with nine inset lights over two panels opening below a transom. Flanking the entrance are large display windows with twenty-four inset lights facing the street and twelve on the canted wall area. The northeast elevation is void of any openings. The rear elevation, clad in wood clapboard siding and wood plank siding, is pierced by a single metal door with a one-over-one, vinyl hopper window above. A concrete stoop with metal railings provides access to this secondary entrance. The southwest elevation is void of any openings. The character-defining element of the building is its display window and entrance.
