PROPERTY REPORT

Property Name: 3 North Main Street
Address: 3 N Main ST
Ownership: Private
Apartment #:
ZIP: 08512

Survey Name: Cranbury CLG Survey 2017

Organization: RGA, Inc.

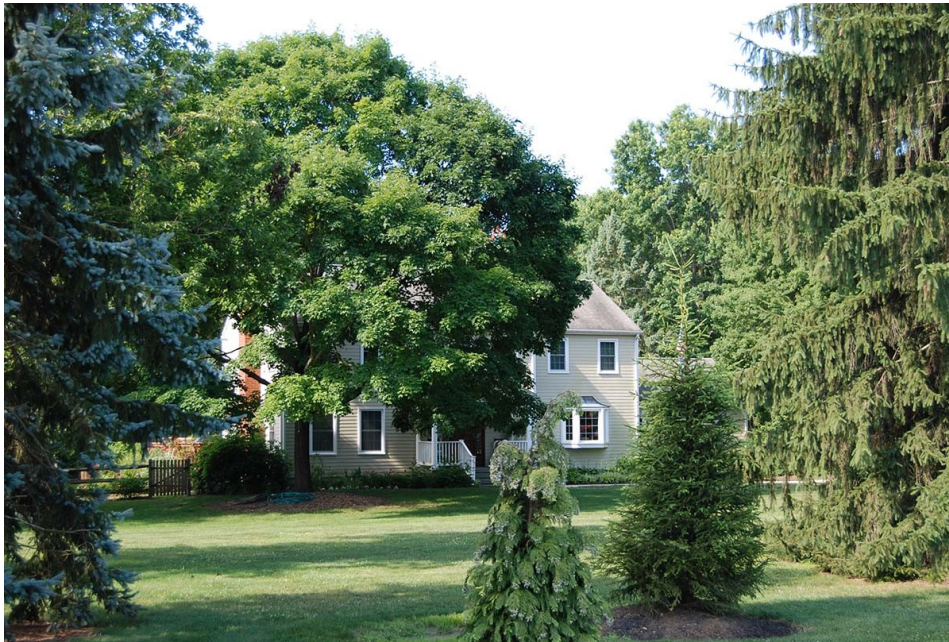
Property Photo:

3 North Main Street is a two-story tall, five-bay wide, two-bay deep, frame private residence constructed circa 1970 in a vernacular style. The dwelling consists of a rectangular, side-gabled main block and an one-story, one-bay L-shaped addition, containing an attached garage, abutting the southwest corner of the dwelling. The roof is sheathed with asphalt shingles. An exterior brick chimney pierces the roof on the east elevation of the main block. The exterior of the dwelling is clad in vinyl siding on all elevations. Windows on the front (north) elevation of the main block and one-story garage are six-over-six vinyl-sash. A vinyl bay window with a copper cap, consisting of a twelve-light window flanked by narrow eight-light windows, sits in the west bay of the main block. The central entrance is a six-panel wood door with segmented sidelights and a segmented, rectangular transom. A front-gabled entry porch with unfluted Doric columns and a low railing with square balusters shelters the entrance. Windows on the west elevation are six-over-six vinyl-sash. The west elevation of the garage features two metal roll-top garage doors. The rear (south) elevation is not visible from the public right-of-way. Windows on the east elevation are six-over-six vinyl-sash. A wood deck wraps around from the west elevation to the rear of the dwelling.

The 1989 Heritage Studies survey identified 3 North Main Street as a non-contributing property to the Cranbury Historic District. The subject dwelling was moved outside of the district boundary circa 1990. RGA recommends the removal of 3 North Main Street from the Cranbury Historic District due to its current location outside of the district boundary.

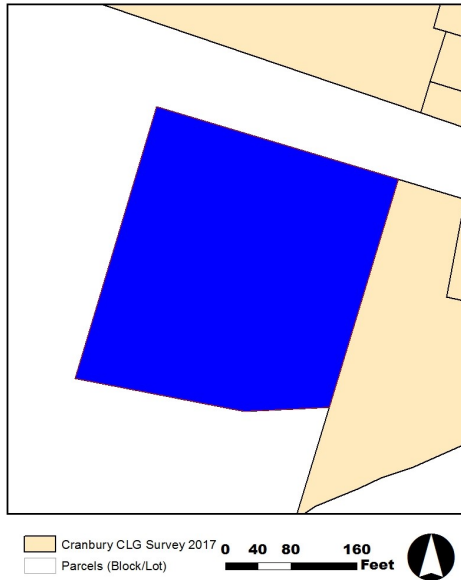
Site Map:

3 North Main Street is sited on a rectangular parcel (Block 23, Lot 70.1) located approximately 700 feet west of North Main Street in Cranbury Township, Middlesex County, New Jersey. The dwelling is oriented with its primary elevation facing north. The property is accessed via an unnamed gravel road that leads west from North Main Street. A paved driveway runs south from the unnamed gravel road to the dwelling's west elevation. The property is lightly wooded. 3 North Main Street is located in a mixed commercial and residential neighborhood surrounded by commercial and residential properties dating from the mid-nineteenth to the early twentieth century.
