PROPERTY REPORT

Property Name: 10 South Main Street **Ownership:** Private
Address: 10 S MAIN ST **Apartment #:** **ZIP:** 08512

Survey Name: Cranbury Local Historic District Survey 2018

Organization: Paulus, Sokolowski & Sartor

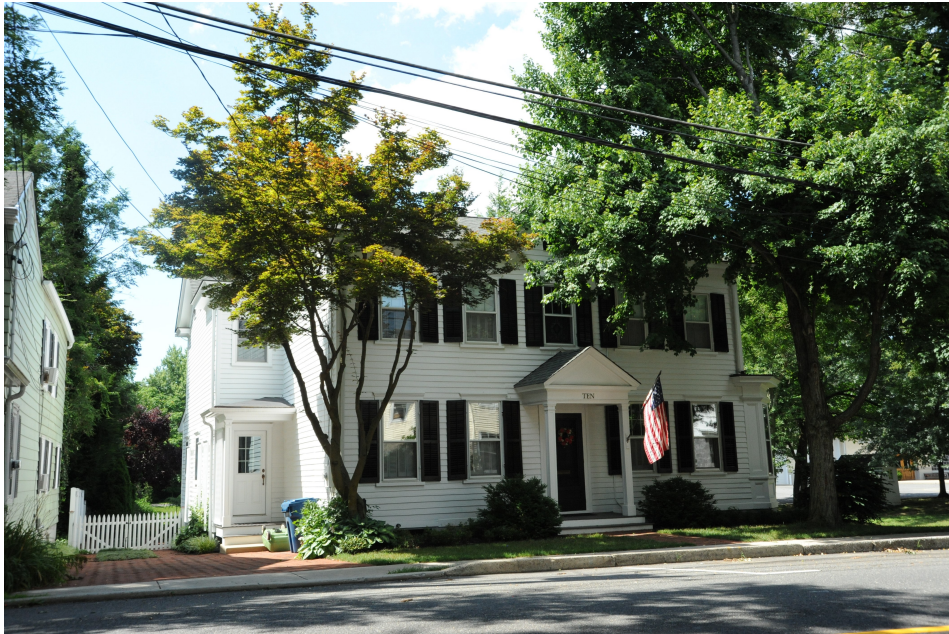
Property Photo:

The 2-story, gable-roofed, rectangular-plan main block of this replacement clapboard-clad, frame dwelling on a parged foundation is 5 bays wide and 2 bays deep and is fronted on the southeast by a 1-story, gable-roofed, 1-bay wide entry porch and backed on the northwest by a 2-story, cross gable-roofed, 3-bay deep, altered rear volume that wraps around the southwest, side elevation and is clad in cement board and includes replacement window sash. A wall gable is located in the central bay of the southeast elevation and a 1-story, composite-roofed, 3-sided window bay is in the southeast bay of the northeast elevation. The roofs are predominantly clad in asphalt single and the windows have 6/1 historic wood sash with historic louvered wood shutters. Interior, brick, ridge chimneys are located near the ends of the main volume. The replaced front entry porch, located in the central bay of the southeast, main elevation, includes historic, square-section posts with recessed panels and a pedimented gable. The primary entrance, located in the central bay and accessed by the porch, includes a historic paneled door and historic storm door. The remaining bays of both floors are regularly fenestrated. A shuttered, segmental arch window lights the wall gable. The northeast, side elevation is lighted by 3 windows with stained glass upper sash in the window bay and a single window in the east bay of the second floor of the main block. The rear volume is lighted by a single window on each floor. The northwest, side elevation is not visible from the public right-of-way. The southwest, side elevation is lighted by 2 windows

on the first floor. A secondary entrance with a hip-roofed door hood, located in the southeast elevation of the extended bay of the rear volume, includes a historic, square-section post with recessed panels. A single window lights the second floor. A 1-story, gable-roofed, frame garage with a 1-story, shed-roofed side volume is located to the northwest of the residence.

The residence at 10 S. Main Street is a contributing property in the Cranbury Historic District because it retains integrity and historic, character-defining features such as its historic door and storm door, historic stained glass, and historic shutters. However, the visibility of the large-scale rear volume from the public right-of-way makes this status marginal.
