PROPERTY REPORT

Property Name: 46 South Main Street **Ownership:** Private
Address: 46 S MAIN ST **Apartment #:** **ZIP:** 08512

Survey Name: Cranbury Local Historic District Survey 2018

Organization: Paulus, Sokolowski & Sartor

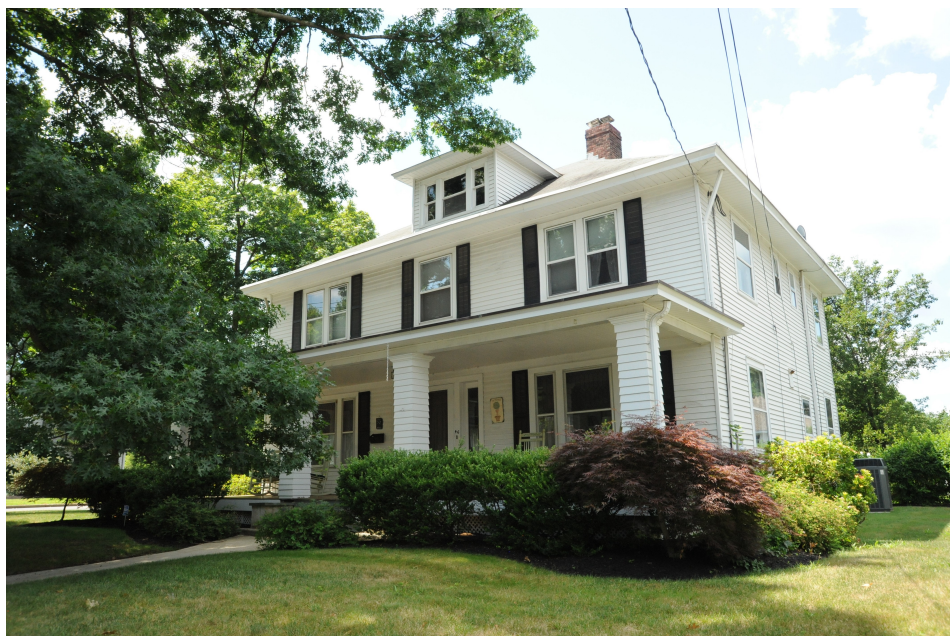
Property Photo:

The 2 ½-story, hip-roofed, foursquare main block of this replacement siding-clad, frame residence on a parged foundation is 3 bays wide and 3 bays deep and is fronted on the southeast by a 1-story, hip-roofed, full-width porch and backed on the northwest by a 1-story, hip-roofed, partial-width rear el offset to the northeast that is flanked on its southwest side by a 1-story, shed-roofed volume. A 1-story, hip-roofed, enclosed porch projects from the central bay of the southwest, side elevation, with a hip-roofed, abutting oriel to the southeast and a 2-story, hip-roofed, 3-sided window bay abutting it to the northwest. Hip-roofed dormers project from the southeast and northwest roof slopes and an interior brick chimney projects from the northeast slope, near the peak. The roofs are predominantly clad in asphalt shingle and the windows predominantly retain 1/1 historic wood sash, with applied vinyl shutters on the main elevation. The front porch, accessed by a centered stair, includes wood clapboard-clad, square-plan posts. The centered main entrance includes historic, single-light side lights. The outer bays of the first floor are both lighted by triple windows with a larger sash flanked on each side by a smaller, 1/1 sash. The second floor is lighted by a single window in the central bay and double windows in the outer bays. The dormer is lighted by a triple window with smaller side sash on a smaller scale than those of the first floor. The northeast, side elevation is regularly fenestrated, though the window size is smaller in the central bay. The southwest, side elevation is regularly fenestrated, with a paired window in the first floor oriel.

The enclosed porch covers the southeast side of the window bay. The porch is lighted by paired, triple awning windows on each elevation except the southeast, which is lighted by a single set of windows and accessed by an adjacent secondary door. The northwest, rear elevation is not visible from the public right-of-way. The 1-story, hip-roofed, clapboard clad garage includes exposed rafter tails and windows with historic 16/1-light, wood sash.

46 S. Main Street is a contributing property in the Cranbury Historic District because it retains integrity and character-defining historic features such as its historic massing, historic window sash, and historic door surround. The garage retains its historic window sash, exposed rafter tails, and siding materials.
