PROPERTY REPORT

Property Name: 10 Cranbury Neck Road **Ownership:** Private
Address: 10 Cranbury Neck RD **Apartment #:** **ZIP:** 08512

Survey Name: Cranbury Historic Sites Survey Phase III

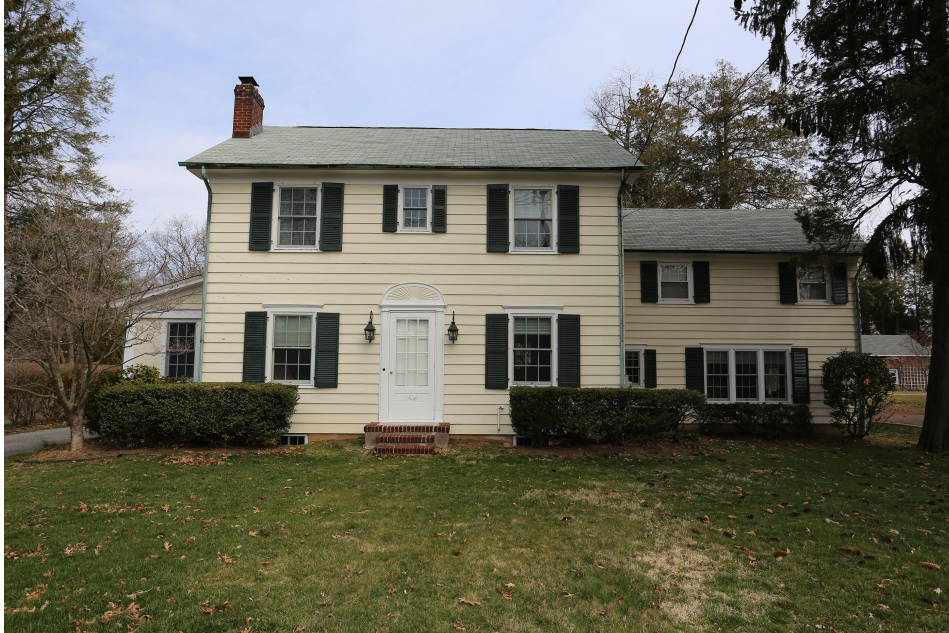
Property Photo:

10 Cranbury Neck Road is a two-and-one-half-story-tall, three-bay-wide, two-bay-deep, frame dwelling built circa 1932 in the Colonial Revival style. The dwelling consists of a side-gabled main block with a two-story-tall, side-gabled, east addition (added in 1939), a one-story-tall, shed-roof, west wing (formerly a porch, now enclosed), and a one-story-tall, hipped-roof, rear (north) wing. An off-center, exterior brick chimney pierces the west gable end of the main block. The roof is sheathed in asphalt shingles throughout and features a molded wood cornice with gable end returns on the main block and east addition. A wood frieze accents the roof line on the primary (south) elevation of the main block and the east addition. The exterior of the dwelling is clad in wood clapboard siding. Windows throughout are six-over-six, vinyl-sash replacement units set within wood surrounds with slightly molded lintels (original). Louvered vinyl shutters flank the windows on the primary elevation of the main block and east addition. The primary elevation of the main block has symmetrical fenestration. The central, primary entrance contains a wood paneled door with a glazed vinyl storm door (added circa 2008), set within a wood surround with unfluted pilasters and a semicircular sunburst motif (original). The entrance is accessed by a concrete and brick stoop. The east and west elevations of the main block have symmetrical fenestration, with semicircular vinyl replacement windows in the gable ends. The east addition contains single and grouped, vinyl-sash replacement windows on its primary and east elevations. The west addition features square wood columns supporting a plain wood frieze, with a vinyl-sash window on the primary elevation. On its west elevation, there is a secondary entrance containing a wood paneled door and a glazed vinyl screen door. The rear elevation is not visible from the public right-of-way. The dwelling stands atop a parged foundation.

Character-defining elements of the dwelling include its massing, fenestration pattern, wood window surrounds, molded wood cornice with gable-end returns, and wood door surround with sunburst motif.
