PROPERTY REPORT

Property Name: 119 North Main Street **Ownership:** Private
Address: 119 N Main ST **Apartment #:** **ZIP:** 08512

Survey Name: Cranbury Historic Sites Survey Phase III

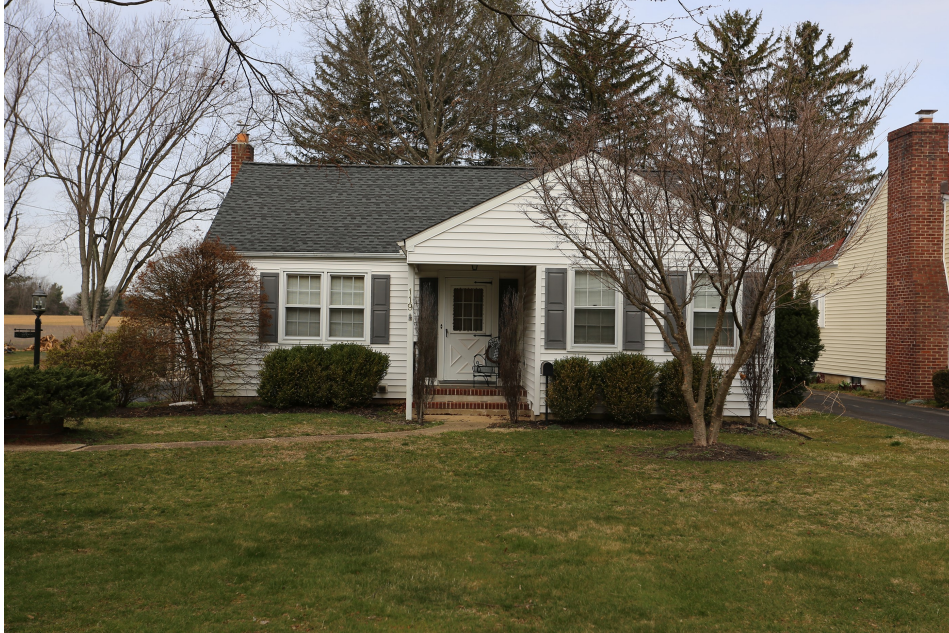
Property Photo:

119 North Main Street is a one-story-tall, four-bay-wide, three-bay-deep, frame dwelling built circa 1948 in the Minimal Traditional style. The dwelling consists of a gable-and-wing main block with a two-bay-wide, front-gabled wing extending from the primary (southeast) elevation. Another one-bay-wide, gabled wing extends from the southern bay of the rear (northwest) elevation with a shed-roof enclosed porch located in the northern bays. An exterior brick chimney extends above the southwest gable end of the main block. The roof is sheathed in asphalt shingles. The exterior of the dwelling is clad in vinyl siding. Windows are primarily six-over-six, vinyl-sash, replacement units flanked by inoperable, vinyl paneled shutters on the primary, northeast, and southwest elevations. The central, primary entrance is sheltered by a porch with wood posts that extends from the front-gable wing. It contains a metal screen door with a multi-light, wood door and is accessed by a concrete and brick stoop. The northeast elevation of the enclosed porch contains grouped vinyl casement windows. The rear elevation is not visible from the public right of way. The dwelling stands on a parged foundation.

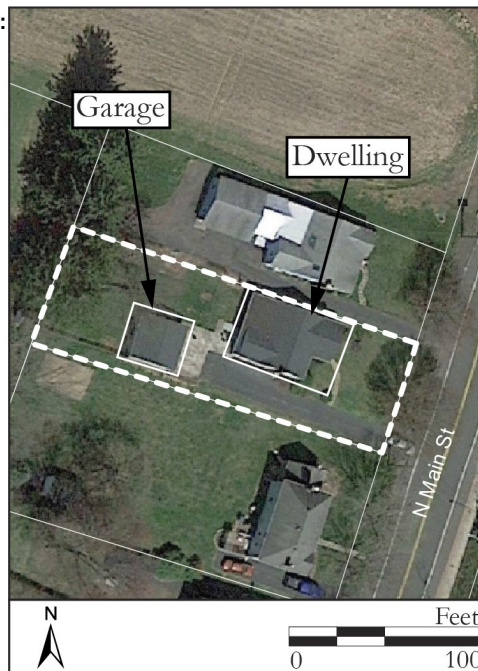
Site Map:

119 North Main Street is sited on a rectangular parcel (Block 25, Lot 26) located on the northwest side of North Main Street in Cranbury Township, Middlesex County, New Jersey. The dwelling is oriented with its primary elevation facing southeast and is set back approximately 40 feet from the road. An asphalt driveway extends along the southwest border of the property. A concrete path extends from the driveway to the primary entry. A concrete patio extends from the rear of the dwelling to the detached garage. Mature trees and
