PROPERTY REPORT

Property Name: 115 North Main Street **Ownership:** Private
Address: 115 N Main ST **Apartment #:** **ZIP:** 08512

Survey Name: Cranbury Historic Sites Survey Phase III

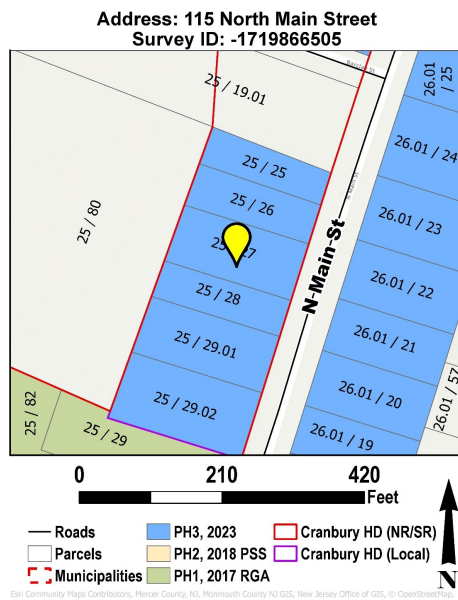
Site Map:

115 North Main Street is sited on a rectangular parcel (Block 25, Lot 27) located on the northwest side of North Main Street in Cranbury Township, Middlesex County, New Jersey. The dwelling is oriented with its primary elevation facing southeast and is set back approximately 30 feet from the road. An asphalt-paved driveway extends along the southwest border of the property. A concrete path extends from the roadway to the primary entrance. A brick path leads from the driveway to the primary entrance. Mature trees and shrubs are planted within close proximity to the dwelling. The subject property is located in a residential neighborhood surrounded by properties dating from the mid-nineteenth to the late twentieth centuries.
