PROPERTY REPORT

Property Name: 113 North Main Street **Ownership:** Private
Address: 113 N Main ST **Apartment #:** **ZIP:** 08512

Survey Name: Cranbury Historic Sites Survey Phase III

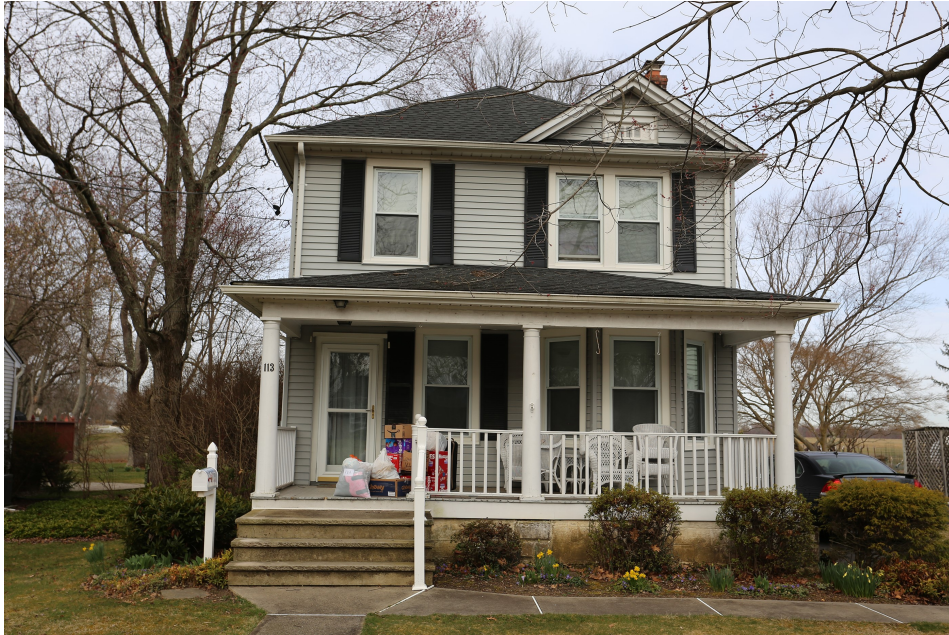
Property Photo:

113 North Main Street is a two-and-one-half-story-tall, three-bay-wide, two-bay-deep, frame dwelling built circa 1910. The dwelling consists of a pyramidal-roof main block with a two-story-tall, two-bay-deep, gable-roof, rear (northwest) addition (added circa 1995). An interior brick chimney rises from the northeast roof slope of the main block. A small, front-gabled dormer is located above the northeast bay of the primary (southeast) elevation and contains a louvered vent. The roof is sheathed in asphalt shingles. The exterior of the dwelling is clad in vinyl siding. Windows throughout are one-over-one, vinyl-sash replacement units, set into vinyl surrounds and flanked by inoperable, vinyl louvered shutters on the primary and southwest elevations of the main block. The primary elevation has asymmetrical fenestration with a full-width, hipped-roof porch with wood Doric columns and a wood balustrade (possibly original) that shelters the first floor (possibly original). The primary entrance is situated in the southwest bay and contains a glazed metal storm door and a wood door with a large rectangular light. Beside the primary entrance, there is a semi-hexagonal projecting bay with three windows. The side (northeast and southwest) elevations feature typical windows, flanked by shutters on the southwest elevation. A secondary entrance, containing a glazed metal storm door, is situated in the northeast bay of the rear addition, and is accessed by wood steps. The rear (northwest) elevation is not visible from the public right-of-way. The main block stands on a rusticated cast-stone foundation, while the rear addition stands on a concrete foundation.

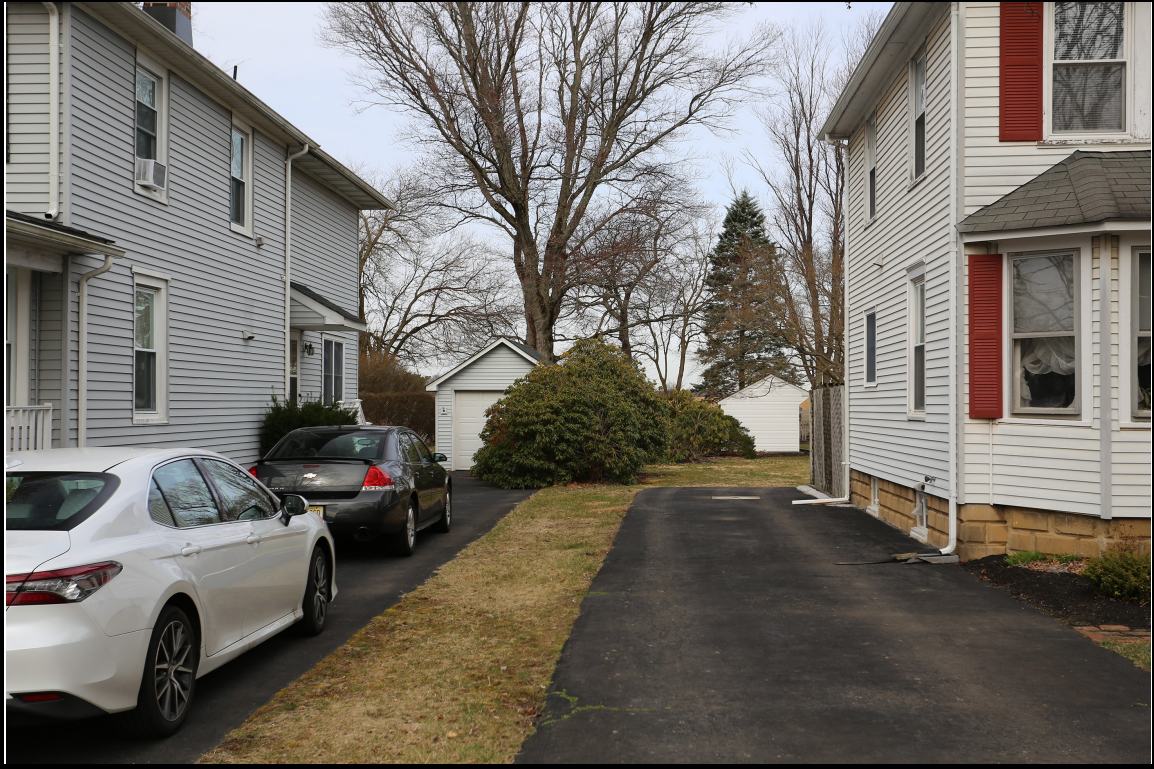
Photo 4

A one-story-tall, one-bay-wide, frame, circa-1910 garage stands approximately 40 feet northwest of the dwelling. The front-gabled roof is sheathed in asphalt shingles and the exterior is clad in vinyl siding. The primary (southeast) elevation features a single metal roll-top door.
