PROPERTY REPORT

Property Name: 156 North Main Street **Ownership:** Private
Address: 156 N Main ST **Apartment #:** **ZIP:** 08512

Survey Name: Cranbury Historic Sites Survey Phase III

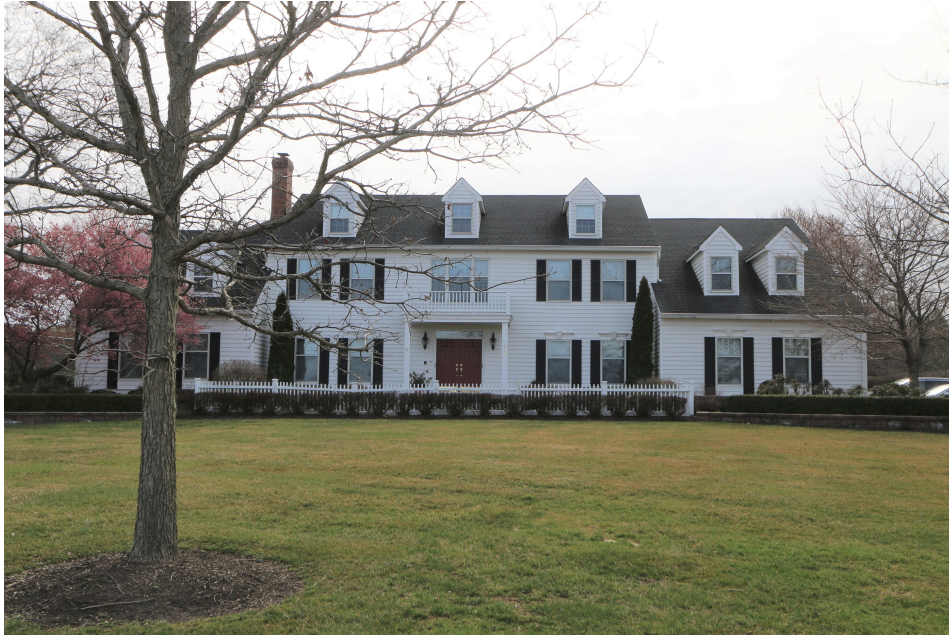
Property Photo:

156 North Main Street is a two-story-tall, five-bay-wide, three-bay-deep, frame dwelling constructed circa 1989 in the New Traditional Colonial Revival style. The dwelling consists of a side-gabled main block with two, one-and-one-half-story side-gabled wings to the northeast and southwest, and two one-story wings on the rear (southeast) elevation. Three, symmetrically placed, front-gabled dormers interrupt the primary (northwest) slope of the main block, and two interrupt the primary roof slopes of the northeast and southwest wings. Asphalt shingles cover the roof throughout. The roof of the main block is accented by a dentillated frieze board which extends across to the northeast and southwest wings. An interior, brick chimney pierces the primary roof slope of the northeast wing. The exterior of the dwelling is clad in vinyl siding, and windows are all vinyl-sash units. The primary elevation of the main block has symmetrical fenestration with eight-over-eight windows on the second floor and eight-over-twelve windows capped with vinyl lintels on the first floor, all flanked by inoperable, vinyl louvered shutters. A tripartite vinyl window is featured in the center bay of the main block's second floor. Located below it, the primary entrance contains a pair of paneled vinyl doors topped with a narrow transom. The entrance is sheltered by a vinyl balcony with vinyl posts and capped with a dentillated cornice and simple vinyl balustrade on the roof. The northeast wing's northeast elevation is obscured by vegetation, and the southwest wing's southwest elevation has asymmetrical fenestration. It features three garage bays with vinyl roll-top doors. The rear elevation contains a central, one-story, shed-roof wing flanked by a semi-hexagonal wing on its southeast elevation. A large exterior brick chimney abuts the southeast elevation of the central wing, which has asymmetrical fenestration. The dwelling stands on a concrete foundation.
