PROPERTY REPORT

Property Name: George Farr Farm **Ownership:** Private
Address: 158 N Main ST **Apartment #:** **ZIP:** 08512

Survey Name: Cranbury CLG Survey 2017

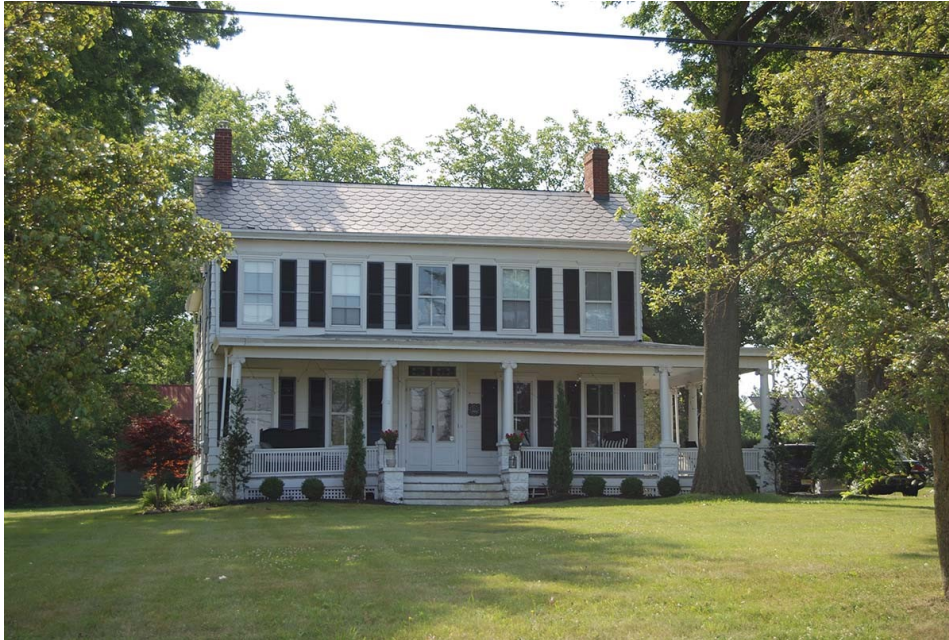
Property Photo:

The George Farr Farm at 158 North Main Street is a two-story tall, five-bay wide, two-bay deep, frame private residence constructed circa 1865 in a vernacular style with the appearance of a formal center hall plan. The dwelling consists of a rectangular, side-gabled main block, a two-story ell and a two-story hipped roof addition to the rear (southwest), a one-story shed roof addition extending from the southwest elevation of the ell, and a one-story enclosed porch extending from the southeast elevation of the ell. The roof is sheathed with slate shingles on the main block and asphalt shingles on the rear additions. Interior brick chimneys pierce the roof at the northeast and southwest gable ends of the main block. The dwelling features a molded wood cornice with a return cornice at the northeast and southwest gable ends. The exterior of the dwelling is clad in aluminum siding on all elevations. Windows on the front elevation are two-over-two, double-hung, replacement wood-sash windows with molded surrounds and molded wood lintels. Inoperable louvered shutters flank the windows. The central entrance consists of paired one-light, one-panel doors topped by a segmented, rectangular transom with a floral stained glass design. The doors are set within a molded wood surround. A one-story, hipped roof porch that wraps around from the front elevation to the southwest elevation shelters the entrance. The porch has Ionic columns set on rusticated concrete block piers and a low railing with thin wood balusters. A narrow louvered window with a molded wood lintel sits in the southwest gable end of the main block. Windows on the southwest elevation of the main block and the rear ell are two-over-two, double-hung, replacement wood-sash windows with molded wood surrounds, molded wood lintels, and inoperable louvered shutters. The enclosed porch on the first floor of the rear ell has metal screen windows and a metal screen door. The rear elevation is not visible from the public right-of-way. A narrow louvered

window sits in the northeast gable end of the main block. Windows on the northeast elevation of the main block, the rear ell, and the two-story hipped roof addition are two-over-two, double-hung, replacement wood-sash windows with molded wood surrounds, molded wood lintels, and inoperable louvered shutters. Character-defining elements of the dwelling include the interior gable end brick chimneys and the one-story wraparound porch with Ionic columns.

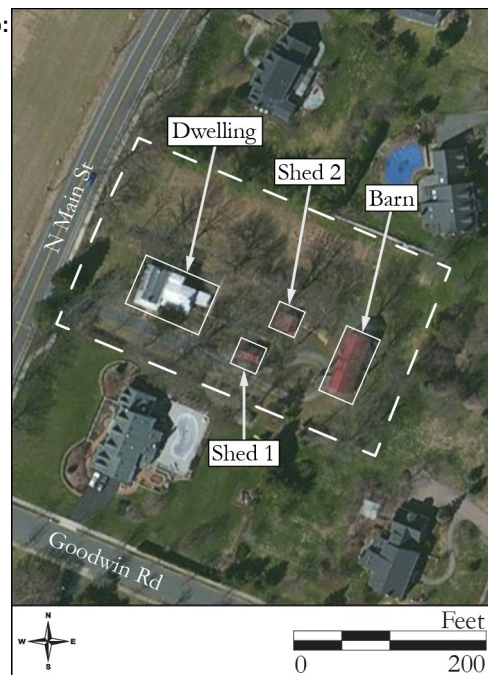
Site Map:

The property contains three outbuildings, located east of the dwelling: a large one-story frame barn with wood plank siding and a standing seam metal roof, and two smaller one-story frame sheds with wood plank siding and standing seam metal roofs. All three outbuildings date to circa 1930.

The George Farr Farm at 158 North Main Street is sited on a rectangular parcel (Block 26, Lot 30) located on the east side of North Main Street in Cranbury Township, Middlesex County, New Jersey. The dwelling is oriented with its primary elevation facing northwest and is set back approximately 50 feet from North Main Street. A concrete sidewalk spans the west side of the parcel. A paved driveway leads east from North Main Street to three outbuildings located west of the dwelling. The property is lightly wooded. The George Farr Farm at 158 North Main Street is located at the northern edge of the Cranbury Historic District surrounded by other residential properties dating from the mid-nineteenth to the late twentieth centuries. Preserved farmland is located west of the parcel.
