# PROPERTY REPORT

**Property Name:** 114 North Main Street **Ownership:** Private  
**Address:** 114 N Main ST **Apartment #:** **ZIP:** 08512

**Survey Name:** Cranbury Historic Sites Survey Phase III

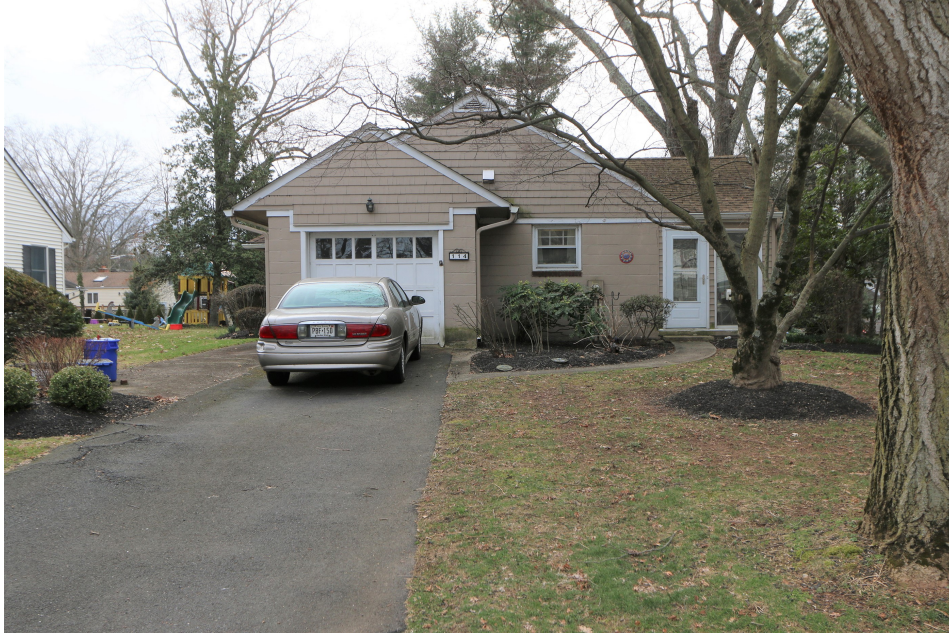
## Property Photo:

114 North Main Street is a one-story-tall, four-bay-wide, five-bay-deep, masonry dwelling constructed circa 1952 in the Minimal Traditional style. The dwelling consists of a front-gabled main block with a one-story, hipped-roof wing that adjoins the rear (southeast) elevation; a one-story, side-gabled, enclosed porch to the southwest (added circa 1960); and a small, one-story addition at the northwest corner of the main block that contains a garage (added circa 1960). The roof is covered with asphalt shingles throughout. The primary (northwest) and southwest gable ends are clad in wood shingles (likely original), with vinyl siding on the southwest enclosed porch. Windows throughout are generally six-over-one, double-hung, wood-sash windows, set into wood surrounds with brick lintels (likely original). The primary (northwest) elevation has asymmetrical fenestration, with a wood, roll-top door in the northwest garage wing, a wood-sash window on the main block, and a full-height, fixed-pane window on the southwest enclosed porch. The primary entrance is located on the southwest enclosed porch and contains a glazed vinyl storm door. The northeast elevation of the main block and the southeast wing have symmetrical fenestration with wood-sash windows. A secondary entrance, containing a glazed vinyl storm door, is located in the northeasternmost bay of the main block. The southwest elevation is largely obscured by vegetation, with full-height, fixed-pane windows visible on the southwest enclosed porch. The rear (southeast) elevation is not visible from the public right-of-way.
