# PROPERTY REPORT

**Property Name:** 120 North Main Street **Ownership:** Private  
**Address:** 120 N Main ST **Apartment #:** **ZIP:** 08512

**Survey Name:** Cranbury Historic Sites Survey Phase III

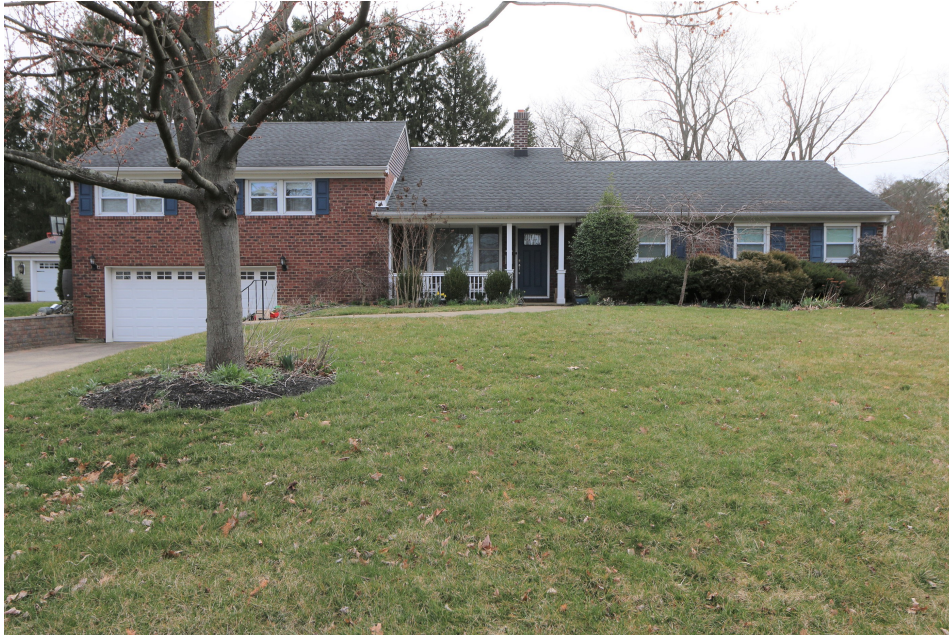
## Property Photo:

120 North Main Street is a two-story-tall, seven bay-wide, two-bay-deep, brick, Tri-Level Split dwelling constructed circa 1955. The dwelling consists of a partially embanked, side-gabled main block and a rear (southeast) gabled addition (built circa 2012). Asphalt shingles cover the roof throughout. The exterior of the dwelling is clad in brick laid in running bond, with vinyl siding in the gable ends. An interior brick chimney pierces the roof ridge of the main block. Windows generally consist of single and grouped, vinyl-sash replacement units with inoperable, louvered vinyl shutters flanking the windows on the primary (northwest) elevation. The two central bays on the primary elevation are recessed, forming an integrated porch supported by square wood posts on square wood pedestals wood posts and a simple wood balustrade. A picture window flanked by one-over-one windows is located in the northern bay beneath the porch and the primary entrance is located in the southern bay. The entrance contains a modern wood panel door with a rectangular light. Situated at the ground level in the northernmost bay of the main block is a single garage bay with a vinyl panel roll-top door. The northeast and southwest elevations have symmetrical fenestration. The rear elevation and the circa-2012 rear addition are not visible from the public right-of-way.
