PROPERTY REPORT

Property Name: 126 North Main Street **Ownership:** Private
Address: 126 N Main ST **Apartment #:** **ZIP:** 08512

Survey Name: Cranbury Historic Sites Survey Phase III

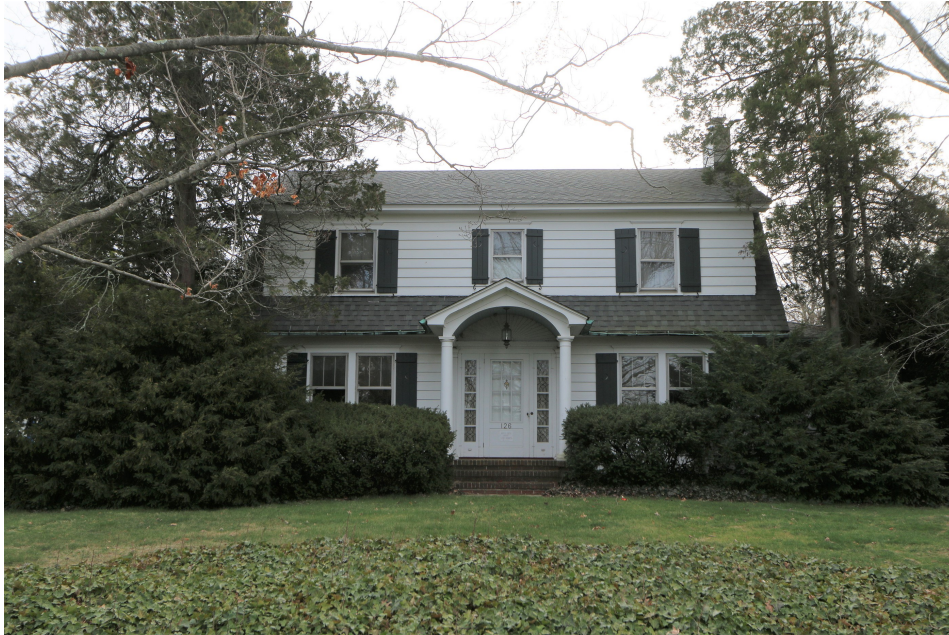
Property Photo:

126 North Main Street is a two-story-tall, three-bay-wide, two-bay-deep, frame dwelling constructed circa 1928 in the Dutch Colonial Revival style. The dwelling consists of a gambrel-roof main block with a one-story, hipped-roof, southwest wing; a one-story, hipped-roof, northeast porch; and a one-story, shed-roof addition on the rear (southeast) elevation (added circa 1965). Full-length, shed-roof dormers interrupt both roof slopes of the main block. Asphalt shingles cover the roof throughout. The roof of the main block is accented by overhanging eaves. An exterior brick chimney is centered on the southwest elevation. The exterior of the dwelling is clad in wood clapboard siding. The primary (northwest) elevation has symmetrical fenestration with paired, three-over-one, wood-sash windows (historic, likely original) on the first floor and second floor, flanked by wood batten shutters that feature crescent moon cutouts and metal shutter dogs (historic, likely original). Windows on this elevation are all set within wood surrounds with slightly molded lintels (historic, likely original) with metal storm windows. The central, primary entrance contains a 12-light, wood door (historic, likely original), set within a wood surround with a dentillated lintel, wood transom with a sunburst motif, segmented sidelights and fluted wood pilasters (historic, likely original). The entrance is sheltered by a front-gable portico with wood Doric columns (possibly historic). Both the northeast and southwest elevations of the dwelling have asymmetrical fenestration and are mostly obscured by heavy vegetation. A central, secondary entrance is visible on the northeast porch, but materials are unclear. The rear addition and rear elevation was not visible from the public right-of-way.

Character-defining elements of the dwelling consist of its massing, gambrel roof with shed-roof dormers, wood-sash windows with wood surrounds, and 12-light wood door with a wood surround.
