# PROPERTY REPORT

**Property Name:** 138 North Main Street      **Ownership:** Private  
**Address:** 138 N Main ST      **Apartment #:**      **ZIP:** 08512

**Survey Name:** Cranbury Historic Sites Survey Phase III

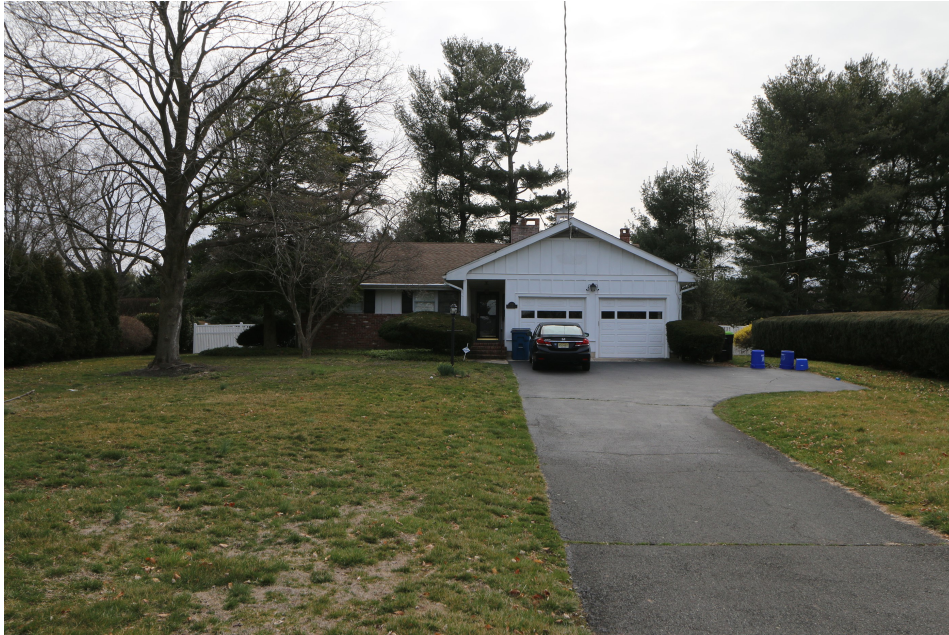
**Property Photo:**

138 North Main Street is a one-story-tall, five-bay-wide, frame, Ranch dwelling constructed circa 1960. The dwelling consists of an L-shaped, cross-gabled main block with a one-story, gable-roof addition extending to the rear (southeast) (added circa 1975). The roof is sheathed in asphalt shingles throughout, with overhanging eaves on the main block. An interior brick chimney pierces the roof of the main block near the junction of the cross gables, and a smaller, exterior brick chimney abuts the southwest gable end of the main block. A small wood cupola sits on the roof ridge of the main block's projecting ell. The exterior of the dwelling is primarily clad in wood board and batten siding, with brick laid in running bond on the lower half of the primary (northwest) elevation and wood clapboard siding in the southwest gable end. Windows are generally single and grouped, six-over-six, vinyl-sash replacement units, with inoperable, louvered vinyl shutters flanking the windows on the primary, northeast, and southwest elevations. The central, primary entrance contains a paneled, wood door (with a metal storm door. The entrance is sheltered by a shed-roof porch within the ell, supported by metal posts with a brick stoop and metal railings. The southwestern bays of the primary elevation, on the projecting ell, contain two paneled wood, roll-top doors (likely original). A secondary entrance with a storm door is present on the southwest elevation of the main block but is obscured by vegetation. The rear addition contains an additional entrance in the westernmost bay. The rear elevation is not visible from the public right-of-way.
