PROPERTY REPORT

Property Name: 128 North Main Street **Ownership:** Private
Address: 128 N Main ST **Apartment #:** **ZIP:** 08512

Survey Name: Cranbury Historic Sites Survey Phase III

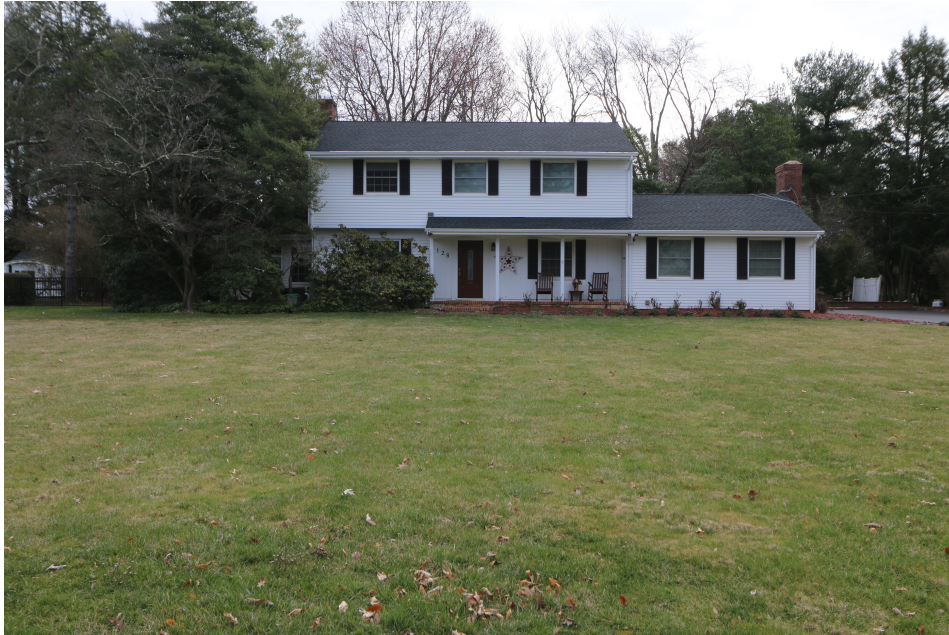
Property Photo:

128 North Main Street is a two-story-tall, three-bay-wide, two-bay-deep, frame dwelling constructed circa 1958. The dwelling consists of a side-gabled main block with a one-story, side-gabled, southwest wing, and a one-story, side-gabled, northeast wing. The roof throughout is covered by asphalt shingles and accented by overhanging eaves. Exterior brick chimneys are centered on the northeast elevation of the main block and the southwest elevation of the southwest wing. The exterior of the dwelling is clad in vinyl siding. Windows are all six-over-six or eight-over-eight, vinyl-sash, replacement units. Inoperable, vinyl louvered shutters flank the windows on the primary (northwest) and southeast elevations of the main block and southwest wing. Located in the center bay of the main block, the primary entrance contains a paneled wood door with a single rectangular light. A one-story, shed-roof porch shelters the two southernmost bays of the main block, supported by square, wood posts. Fenestration on the northeast elevation of the main block and the northeast wing are obscured by coniferous trees. The southwest wing has symmetrical fenestration on the primary and southeast elevations. A walkway covered by a gable roof connects the rear (southeast) elevation of the wing to a circa-1965 garage. The rear elevation of the dwelling was not visible from the public right-of-way.

A one-story-tall, two-bay-wide, frame garage, built circa 1965, sits approximately 8 feet southeast of the dwelling, connected by a covered walkway. The side-gabled roof is clad in asphalt shingles and accented by overhanging eaves. Vertical wood paneling covers the exterior. The primary (southwest) elevation contains two vinyl paneled, roll-top garage doors. The rear (northeast) and the southeast elevations are not visible from the public right-of-way.
