PROPERTY REPORT

Property Name: 87 North Main Street **Ownership:** Private
Address: 87 N Main ST **Apartment #:** **ZIP:** 08512

Survey Name: Cranbury CLG Survey 2017

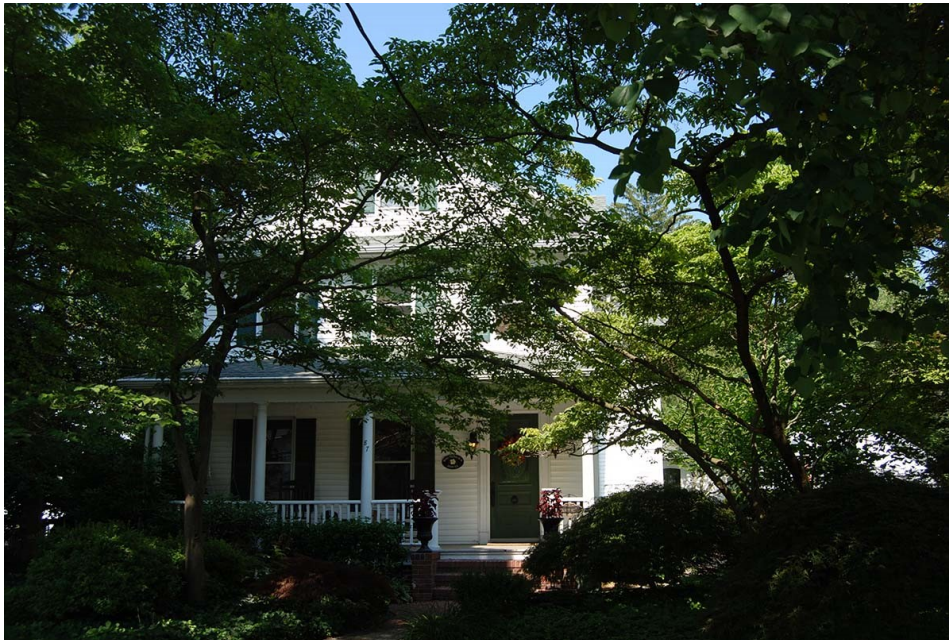
Property Photo:

87 North Main Street is a two-and-a-half-story, three-bay, five-pile wide, frame vernacular residence constructed in 1912. The original building was extended to the rear circa 1990.

The house has an overall front gabled orientation, but cross-gabled bays on the sides create a cross-gabled shape. The roof is sheathed with asphalt shingles and includes a full return cornice on the main elevation that creates a pedimented attic level. Two interior brick chimneys pierce the roof: one at the ridgeline (in the center of the original house) and one on the south side. The exterior of the dwelling is clad in wood clapboard siding on the front elevation and aluminum siding on all other elevations. Fenestration consists of one over-one vinyl-sash windows with louvered, inoperable, replacement shutters. Windows on the first floor are set within molded wood surrounds. The entrance, located in the northeast corner of the building, consists of a one-light, two-panel wood door within a molded wood surround. The first floor is sheltered by a one-story porch with a hipped roof, Doric columns, and wood balusters. Brick stairs lead from the porch down to the grade of the front lawn.

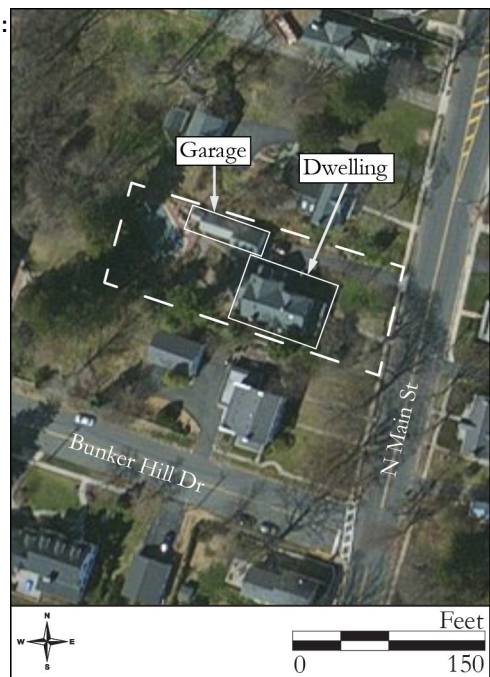
Site Map:

87 North Main Street is sited on a rectangular parcel (Block 28, Lot 9) located on the west side of North Main Street in Cranbury Township, Middlesex County, New Jersey. The dwelling is oriented with its primary elevation facing southeast and is set back approximately 20 feet from North Main Street. A concrete sidewalk spans the east side of the parcel. Trees are planted along the curb between the dwelling and North Main Street. A paved driveway leads west from North Main Street to a one-story frame garage located northwest of the dwelling. The property is lightly wooded. 87 North Main Street is located in a primarily residential neighborhood surrounded by residential properties dating from the mid-nineteenth to the early twentieth centuries.
