PROPERTY REPORT

Property Name: 5 Maplewood Avenue **Ownership:** Private
Address: 5 MAPLEWOOD AVE **Apartment #:** **ZIP:** 08512

PS&S recommends that 5 Maplewood Avenue, constructed between 1850 and 1876, is a contributing property in the Cranbury Historic District.

Survey Name: Cranbury Local Historic District Survey 2018

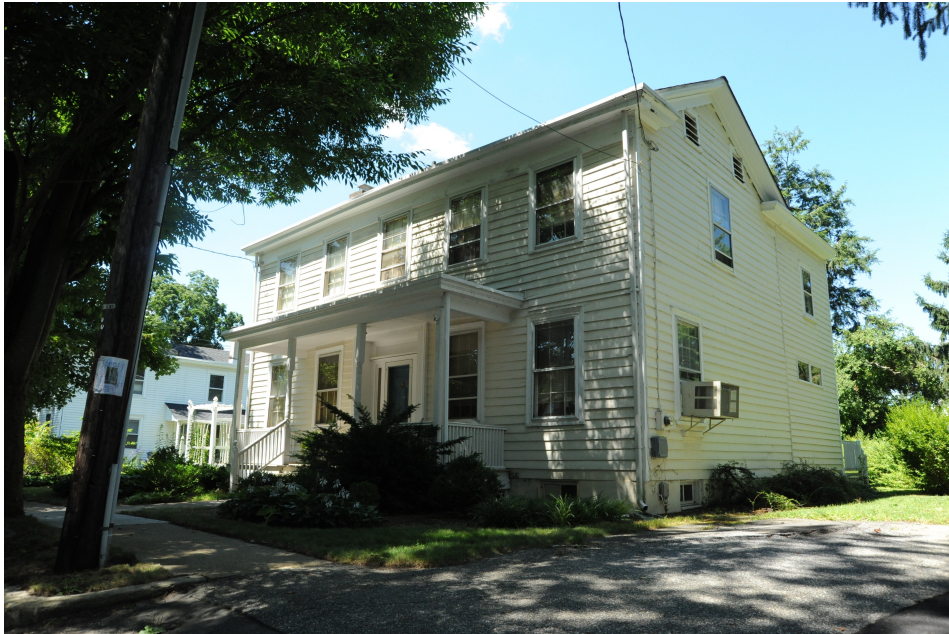
Property Photo:

The 2 1/2-story, rectangular-plan, gable-roofed, clapboard-clad main volume on a parged foundation of this frame residence is 6 bays wide and 3 bays deep and is backed on the northwest by a partial-width, 2-story, composite-roofed, 5-bay wide and 1-bay deep rear volume, which is backed in turn by a 1-story, partial-width, shed-roofed rear el. A 1-story, composite-roofed, partial-width, centered porch projects from the southeast, main elevation, and a 1-story, hip-roofed porch flanks the rear volume on the southwest, side elevation. An interior, stuccoed chimney projects from the southwest bay of the gable ridge. Excluding the composite roofs, the roofs throughout are clad in asphalt shingle. The windows predominantly have 6/6, historic wood sash. The wood porch on the southeast, main elevation is accessed by a straight concrete stair and includes replaced, square plan outer posts, historic turned posts flanking the central stair, and a handrail with square-plan banisters. The house is primarily accessed through a historic door in the central bay of the main elevation. The entrance includes historic sidelights and a covered transom. Each of the remaining bays contains a window on both floors. The northeast, side elevation includes a window in the southeastern bay of the first floor and a central window on the second floor. The rear volume includes a replaced, double, fixed window on the first floor and a window on the second floor. The northwest, rear elevation is only partially visible from the public right-of-way and includes an added window bay on the second floor and a single window in the south bay of the second

floor. Two added skylights light the rear el. The southwest, side elevation includes a window in each of the outer bays except the west bay of the second floor. Both side elevations include 2 louvered vents under the gable peak. A single window lights the southwest side of the second floor of the rear volume. A secondary entrance, not visible from the public right-of-way, is accessed by the side porch.

This property is a contributing property in the historic district because it retains integrity and historic character-defining features such as its historic massing and fenestration patterns, historic wood clapboard cladding, historic wood windows and doorway, and historic porch details.
