PROPERTY REPORT

Property Name: 23 Maplewood Avenue
Address: 23 MAPLEWOOD AVE

Survey Name: Cranbury Local Historic District Survey 2018

Organization: Paulus, Sokolowski & Sartor

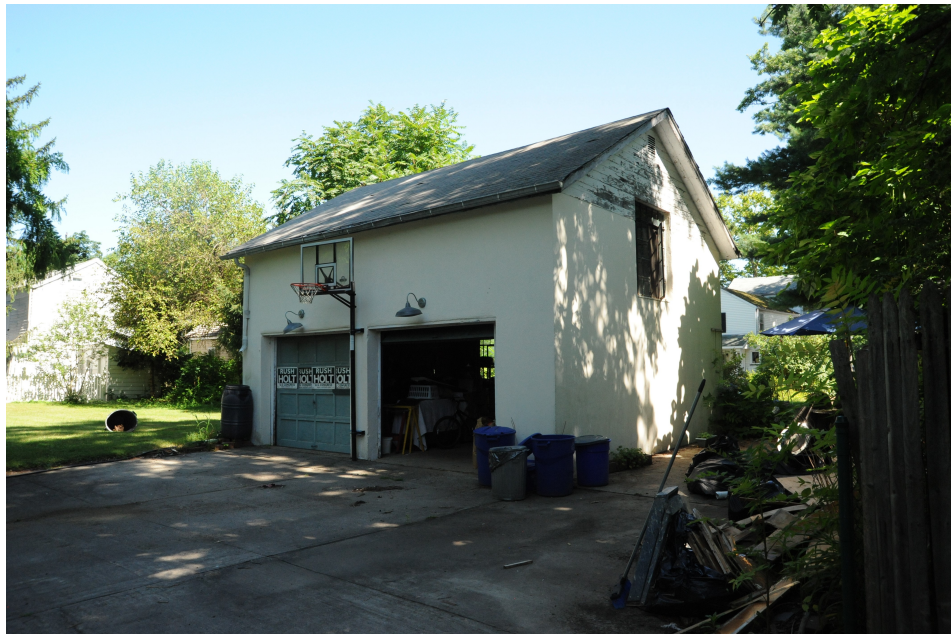
Property Photo:

PS&S recommends that the garage at 23 Maplewood Avenue, constructed between 1940 and 1953, is a non-contributing property in the Cranbury Historic District.

The 1 ½-story, gable-roofed, frame, clapboard and stucco-clad garage is partially visible from the public right-of-way and includes 2 wood sectional garage doors on the south elevation and a 16-light casement window with 4-light sidelight and transom on the east elevation.
