PROPERTY REPORT

Property Name: 23 Maplewood Avenue **Ownership:** Private
Address: 23 MAPLEWOOD AVE **Apartment #:** **ZIP:** 08512

PS&S recommends that the garage at 23 Maplewood Avenue, constructed between 1940 and 1953, is a non-contributing property in the Cranbury Historic District.

Survey Name: Cranbury Local Historic District Survey 2018

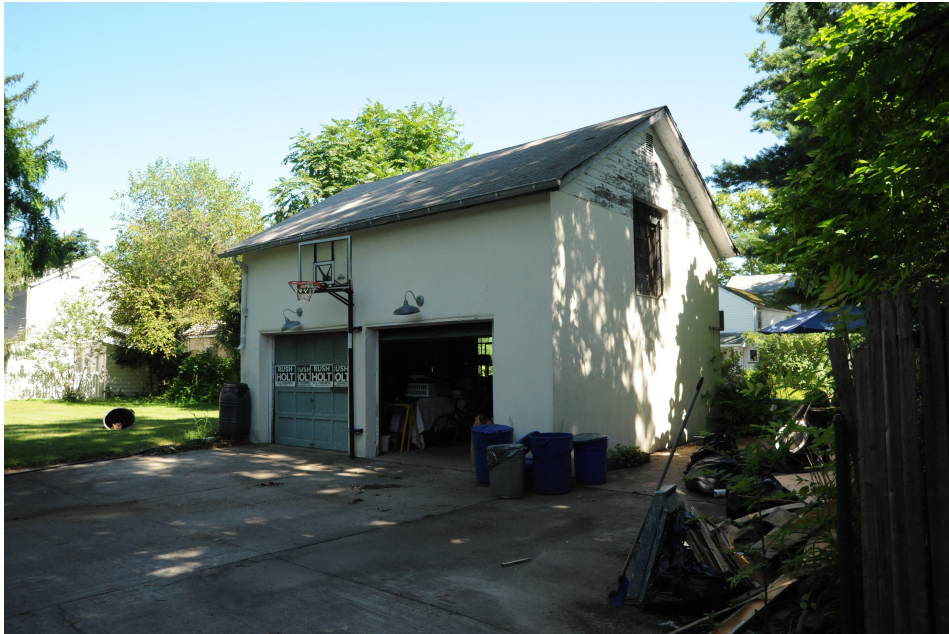
Property Photo:

The 1 ½-story, gable-roofed, frame, clapboard and stucco-clad garage is partially visible from the public right-of-way and includes 2 wood sectional garage doors on the south elevation and a 16-light casement window with 4-light sidelight and transom on the east elevation.
