PROPERTY REPORT

Property Name: First National Bank of Cranbury
Address: 32 N Main ST
Ownership: Private
Apartment #:
ZIP: 08512

Survey Name: Cranbury CLG Survey 2017

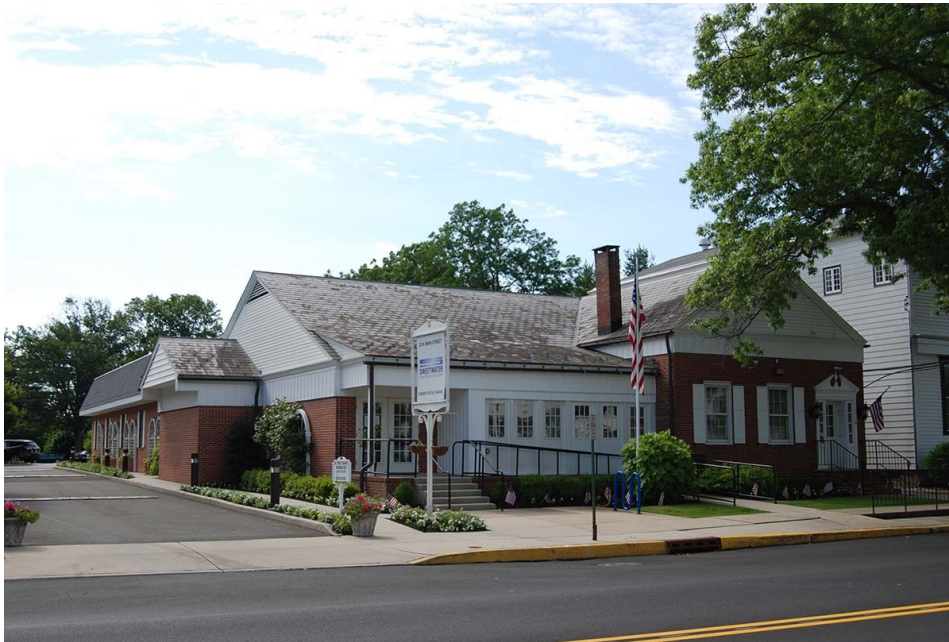
Property Photo:

First National Bank of Cranbury at 32 North Main Street is a one-story tall, three-bay wide, five-bay deep, brick commercial building constructed circa 1884 and extensively renovated in 1953 with Colonial Revival details. The building has multiple additions: a one-story, three-bay wide addition and a two-story, four-bay wide, side-gabled addition on the rear (built circa 1953); a one-story tall, seven-bay wide, side-gabled addition to the northeast (built circa 1976); and a one-story, five-bay wide, hipped roof addition to the northeast (built circa 1984). The roof is clad in slate shingles on the main block and circa 1976 addition, with asphalt shingles on the circa 1953 and circa 1984 additions. An interior brick chimney pierces the roof on the northeast slope of the main block. The exterior of the building is faced with brick on all elevations with vinyl siding in the gable ends and faux board and batten siding on the front elevation of the circa 1976 addition. A faux board and batten frieze runs beneath the eaves on the front and side elevations. A clock perforates the the front gable end of the main block. The front elevation of the main block has two six-over-six, double-hung, replacement wood-sash windows with aluminum storm windows, flanked by inoperable paneled shutters. The 1976 addition has nine-light fixed vinyl windows arranged in a row and separated by simple square pilasters. A bronze deposit box is located in the northwest corner of the main block, below one of the windows. The entrance to the main block, located in the south bay, is a single nine-light, two panel wood door with segmented sidelights above rectangular panels. A broken pediment featuring a carved urn tops the door. This entrance is accessed by a brick stoop with wrought iron railings. Another entrance, two single doors with fifteen inset lights each, is located in the north bay on the 1976 addition. This entrance is recessed and accessed by a concrete stoop and ramp with metal railings.

The northeast elevation features a projecting bay with a front-gabled roof and a faux board and batten frieze. This projecting bay, void of any openings, is a remnant of a drive-up service window that was added to the building circa 1953 and removed circa 2014. Windows on the northeast elevation are nine-over-nine, vinyl-sash windows with inoperable paneled shutters on the circa 1953 and circa 1984 additions. The southwest elevation also has nine-over-nine, vinyl-sash windows on the main block and the circa 1953 rear additions. A metal box with a rounded top, labeled "security alarm," is located in the west corner of the elevation, above one of the windows.
