PROPERTY REPORT

Property Name: 48 Maplewood Avenue **Ownership:** Private
Address: 48 MAPLEWOOD AVE **Apartment #:** **ZIP:** 08512

Survey Name: Cranbury Local Historic District Survey 2018

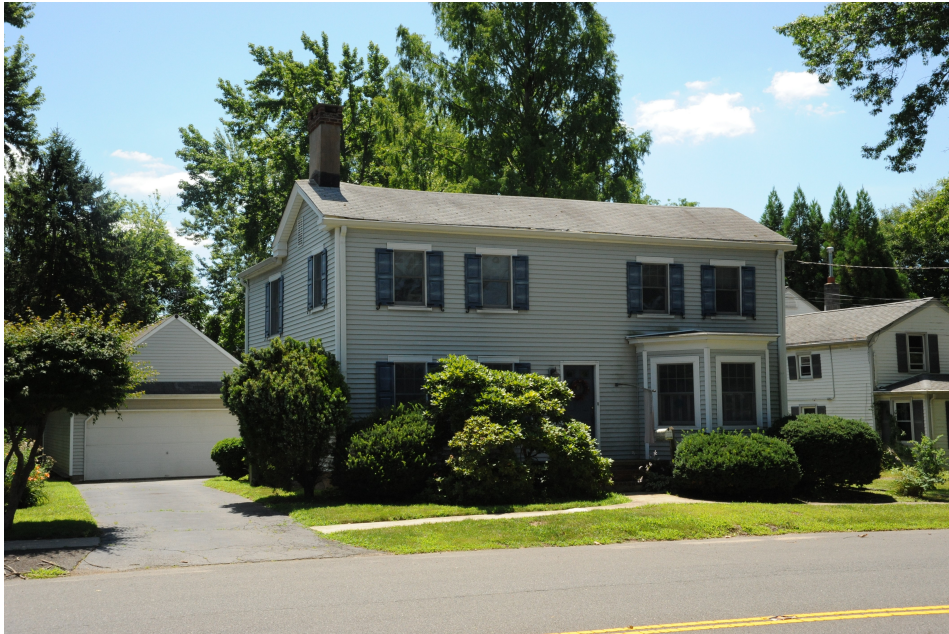
Property Photo:

The 2-story, gable-roofed, rectangular-plan, main block of this vinyl siding-clad, frame residence on a parged foundation is 5 bays wide and 2 bays deep and is fronted in the southwestern bay of the northwest elevation by a 1-story, composite-roofed, 3-sided projecting bay and backed on the southeast by a 2-story, gable-roofed, altered rear volume in 2 sections. The roofs are predominantly clad in asphalt shingle and the windows have 6/1 replacement sash with replacement shutters. A substantial, brick, interior, ridge chimney projects from the northeast bay of the main volume. The primary entrance, located in the central bay of the northwest, main elevation, includes a replaced metal door. The projecting front bay, is lighted by 3, 8/1 replacement windows. Each of the remaining bays of both floors are lighted by a single window. The southwest, side elevation is lighted by a single window on the second floor of the main block and 2 fixed windows in the rear el. The southeast, rear elevation is not visible from the public right-of-way. The northeast, side elevation is lighted by a single window on each floor of the main block and of the rear volume.

This property is a non-contributing property in the historic district by virtue of the building's loss of integrity from extensive alterations in multiple periods, in which all historic exterior materials were replaced, historic chimneys removed, and the historic massing of the building was altered by a substantial addition that is partially visible from the public right-of-way.
