PROPERTY REPORT

Property Name: 36-38 Maplewood Avenue **Ownership:** Private
Address: 36-38 MAPLEWOOD AVE **Apartment #:** **ZIP:** 08512

Survey Name: Cranbury Local Historic District Survey 2018

Organization: Paulus, Sokolowski & Sartor

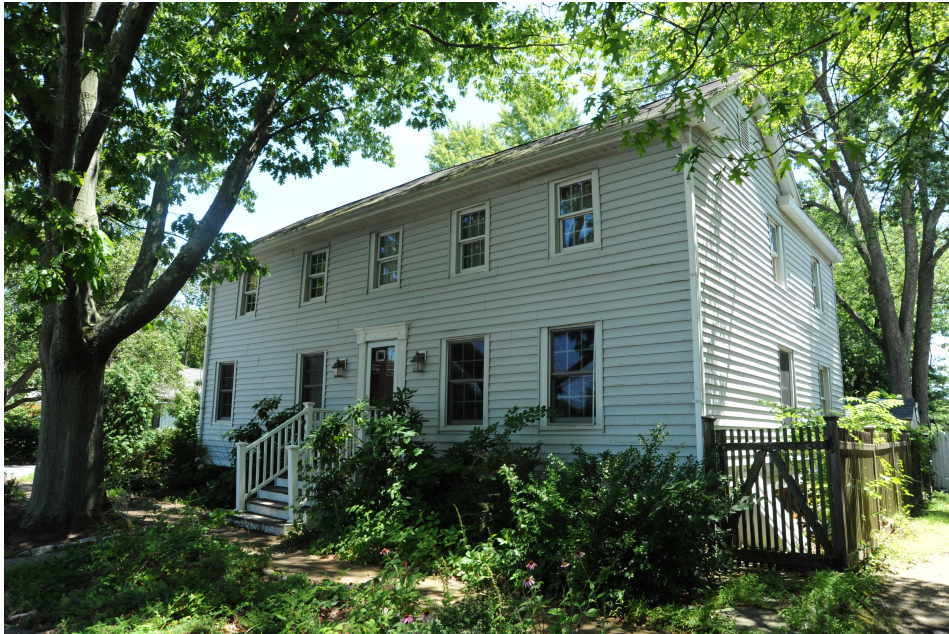
Property Photo:

The 2-story, gable-roofed, rectangular plan, composite siding-clad, main block of this residence on a stuccoed foundation is 6 bays wide and 2 bays deep and is backed by a 2-story, composite-roofed, full-width, altered secondary volume and a large, 1-story, combination shed- and gabled-roofed rear addition. The roofs are predominantly clad in asphalt shingle and the windows throughout have double-hung replacement sash with applied muntins. The primary entrance is roughly centered on the northwest, main elevation and includes a replacement door fronted by an added entrance stair. Each of the remaining bays includes a window on both floors except for the interior northeast bay. The window of the northeast bay of the first floor is offset from the window above, reflecting the location of a former door. The southwest, side elevation is lighted by a window on each floor in the south bay of the main block and a window on each floor of the 2-story rear volume. The southeast, rear elevation, only partially visible from the public right-of-way, is lighted by a central double windows and 2 flanking single windows, with a secondary door to the rear porch. The northeast, side elevation is lighted by 2 windows on the first floor and 1 window on the second floor of the main block, with asymmetrical fenestration in the rear volume and a single window in the rear el.

aerial photographs indicate that this residence was constructed after 1876. It was inventoried in the 1980 National Register Nomination for the Cranbury Historic District as dating to the third quarter of the 19th century, and as "altered" although in what way was not noted. The building is detailed in the 1933 Sanborn map as a 2-story, frame, L-plan combination dwelling and store, with a main volume fronted by a 1-story, metal-roofed porch and the northeastern, store section backed by a 1-story, metal-roofed el. The 1974 photographic inventory of Cranbury historic buildings in the collection of the Cranbury Historical and Preservation Society shows the building's northeast and northwest elevation and reflects the organization shown in the Sanborn map, with a full-width front porch with a shingled knee wall accessing 2 entrances. The store entrance was located between the 2 northeastern windows. The photograph also shows 2 brick, ridge chimneys near the ends of the building and the shed-roofed rear el on the store section of the building. Historic aerial photographs do not clearly document the date of the removal of the front porch and recladding of the exterior, but suggest this happened in the late 1970s. Historic aerial photographs indicate a major campaign of addition to the rear of the building took place in 2010.

This property is a non-contributing property in the historic district because it has lost integrity of materials and workmanship through the loss of historic exterior materials, and, with the loss of the front porch, second entrance, and the large scale of the rear addition, has lost integrity of design.
