PROPERTY REPORT

Property Name: 34 Maplewood Avenue **Ownership:** Private
Address: 34 MAPLEWOOD AVE **Apartment #:** **ZIP:** 08512

Survey Name: Cranbury Local Historic District Survey 2018

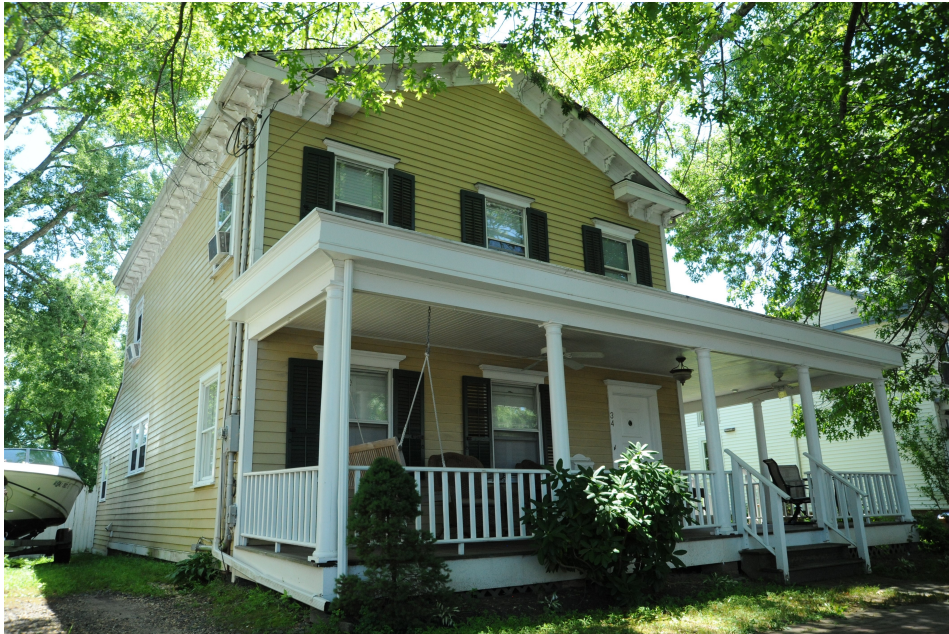
Property Photo:

The 2-story, gable-roofed, rectangular plan, replacement clapboard-clad, main block of the frame residence on a parged foundation is 3 bays wide and 4 bays deep and is fronted by a 1-story, hip-roofed, partial wrap-around front porch and backed by a 1-story, shed- and hip-roofed el that extends beyond the southwest, side elevation and connects to the wrap-around porch on the southwest, side elevation. The roofs are clad in asphalt shingle and include added eave returns and added decorative brackets. The windows throughout have 1/1 replacement sash. The replaced porch on the northwest, main elevation includes replacement columns and a vinyl rail with vinyl balusters. The primary entrance, located in the west bay, includes a replacement door. A window with replacement wood shutters lights each of the remaining bays on both floors. The southwest, side elevation is lighted by a window in the west bay of the first floor and the south bay of the second floor. A window lights each bay of the rear el. The southeast, rear elevation is not visible from the public right-of-way. The northeast, side elevation is lighted by a window on each floor of the north bay, with a single window on the second floor and double window on the first floor of the east bay. The rear el is lighted by a single window.

This property is a non-contributing property in the historic district because of the overall loss of historic exterior fabric before 1974, which led to the loss of integrity of materials and workmanship. Although the porch has been reconstructed, its accuracy relative to the historic porch is not known. Thus, the building has also lost integrity of design.
