## PROPERTY REPORT

**Property Name:** 26 Maplewood Avenue **Ownership:** Private  
**Address:** 26 MAPLEWOOD AVE **Apartment #:** **ZIP:** 08512

**Survey Name:** Cranbury Local Historic District Survey 2018

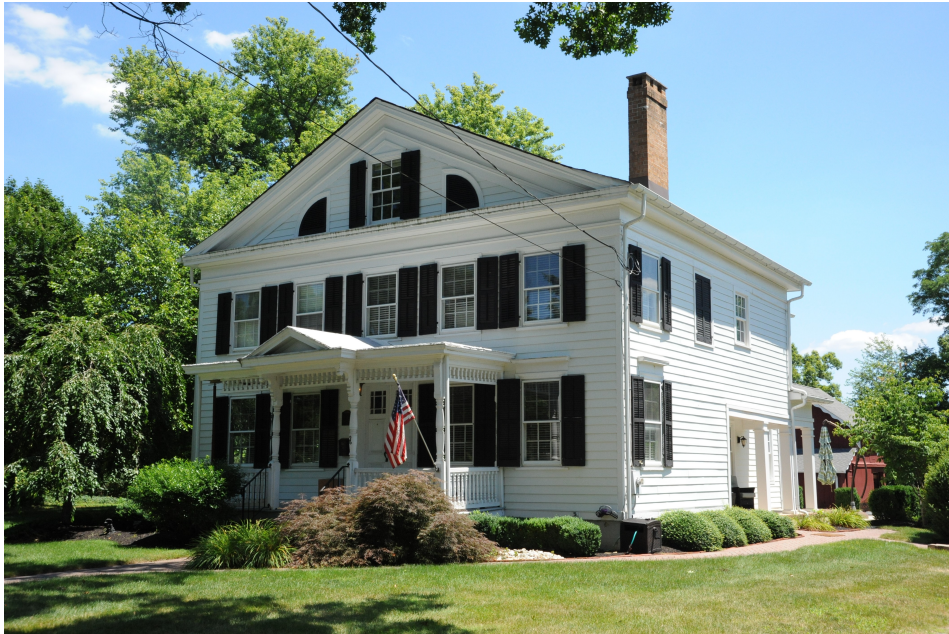
### Property Photo:

The 2 ½-story, gable-roofed, rectangular-plan, clapboard-clad, main block of this frame residence on a brick foundation is 5 bays wide and 4 bays deep and is fronted on the northwest by a 1-story, partial-width, composite-roofed, pedimented front porch and backed on the southeast by a 2-story, gable-roofed secondary volume. The roofs other than that on the porch are clad in asphalt shingle and the windows retain 6/6, double-hung, historic wood sash. A substantial brick chimney projects from the northwest bay of the southwest roof slope. The gable ends of both the northwest and southeast elevations are pedimented. The front porch extends across the central 3 bays of the northwest, main elevation and includes historic turned posts, rail, turned balusters, spindle frieze, and pediment brackets. The primary entrance to the residence, located in the central bay and accessed by the porch, includes historic, double, recessed leaf doors with 9-light upper lights windows with a large central pane. Each of the remaining bays on both floors is lighted by a window with historic wood shutters, with undecorated entablatures over the first floor windows. The third floor is lighted by a single central window with flanking quarter circle shuttered windows. The southwest, side elevation is lighted by a window on the first floor and 3 windows on the second floor. The 2 southeastern bays include a recessed porch that extends 1 bay to the southeast, with a hip-roofed, 1-bay-deep covering. A secondary, replacement sliding door with a flanking window is accessed by the rear porch. A window lights each of the remaining bays of

the rear volume on both floors. The southeast, rear elevation is lighted by a double window on the first floor with a window in each bay on the second floor and a small rose window on the third floor. An additional door with a shed-roof hood is located in the southeast bay. The northeast, side elevation is lighted by a single window in each bay of both floors, with a double window in the southeast bay of the first floor of the main block.

This property is a key contributing property in the historic district because it retains integrity and historic character-defining features such as its historic massing and fenestration patterns, historic porch and front door, historic windows and shutters in most locations, and historic chimney.
