PROPERTY REPORT

Property Name: 18 Maplewood Avenue **Ownership:** Private
Address: 18 MAPLEWOOD AVE **Apartment #:** **ZIP:** 08512

Survey Name: Cranbury Local Historic District Survey 2018

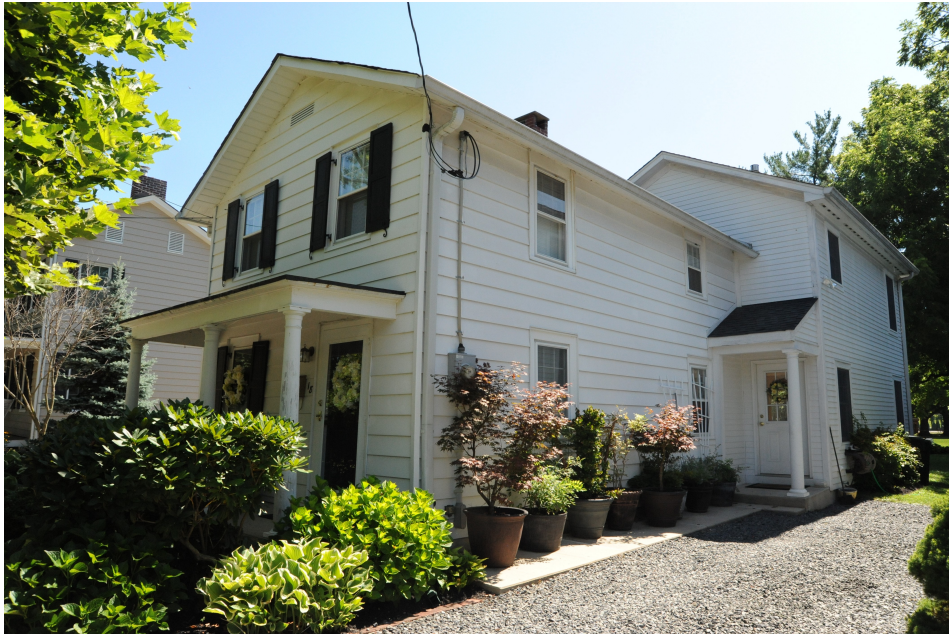
Property Photo:

The 2-story, gable-roofed, rectangular plan, replacement clapboard-clad, main block of this frame dwelling on a parged foundation is 2 bays wide and 3 bays deep. The main block is fronted on the northwest by a 1-story, composite-roofed porch and backed on the southeast by a 2-story, gable-roofed, 3 bay-deep addition. The roofline of the addition is higher than the roofline of the main block. The roofs are predominantly clad in asphalt shingle and the windows in the main volume retain 6/1, historic wood sash. The main volume includes a historic, interior, ridge brick chimney. The primary entrance, located in the southwest bay of the main elevation is accessed by the front porch, which includes replaced Tuscan columns. There is a window with replaced wood shutters in each of the remaining bays on each floor. A secondary, added entrance with a shed-roofed hood on a single Tuscan column is located on the northwest elevation of the addition volume. The southwest, side elevation includes a window in each of the outer bays of both the main block and rear volume. The southeast, rear elevation is not visible from the public right-of-way. The northeast, side elevation contains a window in each of the outer bays on each floor of the main block and a shed-roofed window bay and single window on the first floor and a single window on the second floor of the addition.

This property is a contributing property in the historic district, because it retains integrity and such character-defining historic features as the massing of its historic main volume, historic chimney, and historic wood window sash and front door in its main volume. The scale and visibility of the rear addition, and false sense of history presented by the front porch columns, however, make this status marginal.
