PROPERTY REPORT

Property Name: 16 Maplewood Avenue **Ownership:** Private
Address: 16 MAPLEWOOD AVE **Apartment #:** **ZIP:** 08512

Survey Name: Cranbury Local Historic District Survey 2018

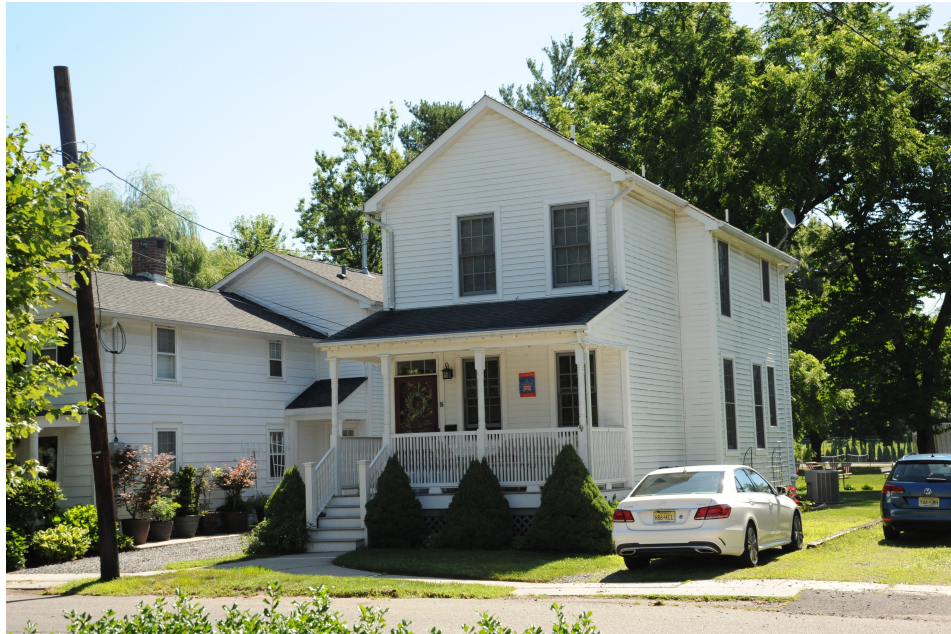
Property Photo:

The 2-story, gable-roofed, rectangular plan, aluminum siding-clad, main block of this frame dwelling on a parged foundation is 2 bays wide and 7 bays deep, and is fronted on the northwest by a 1-story, shed-roofed front porch. A 2-story, 3-bay wide, rectangular-plan projecting bay is roughly centered on the southwest, side elevation. The roofs are clad in asphalt shingle and the windows have 6/6 replacement sash throughout. The porch is accessed by a straight stair in the north bay and includes replaced posts, a replaced rail, and replaced turned balusters. The primary entrance to the house is located in the northeasternmost bay of the northwest elevation, with windows in the other bays on each floor. The southwest, side elevation is only fenestrated in the central projecting bay, with 3 windows on the first floor and 2 on the second floor. The southeast, rear elevation is not visible from the public right-of-way. The northeast, side elevation includes a single window in the central bay of each floor.

This property is a non-contributing property in the historic district by virtue of the building's loss of integrity from extensive alterations in the period 1987-2002, in which all historic exterior materials were replaced, fenestration patterns were changed, and the historic volume of the building was substantially altered such that the change in historic envelope was highly visible from the public right-of-way.
