PROPERTY REPORT

Property Name: 10 Maplewood Avenue **Ownership:** Private
Address: 10 MAPLEWOOD AVE **Apartment #:** **ZIP:** 08512

Survey Name: Cranbury Local Historic District Survey 2018

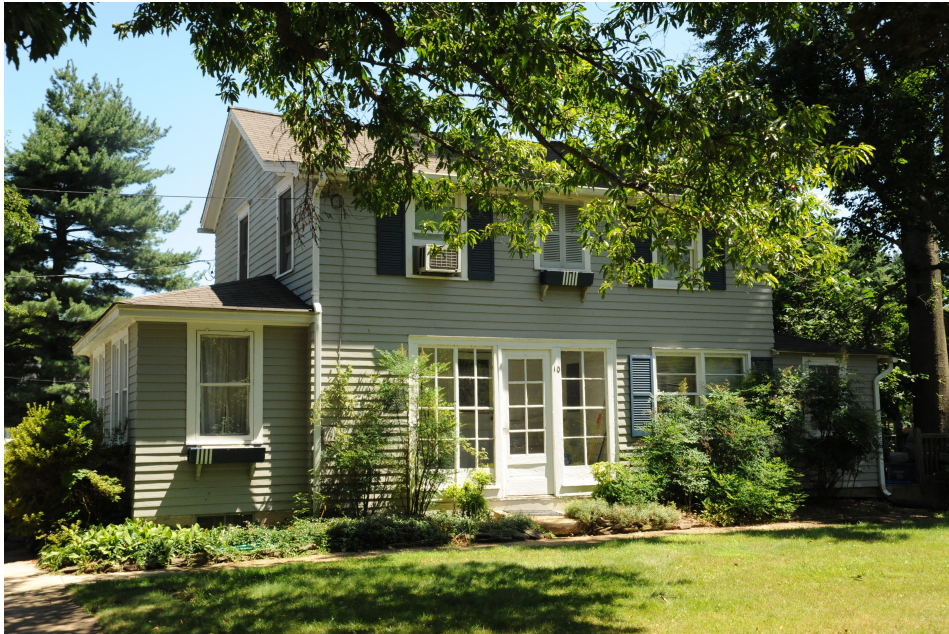
Property Photo:

PS&S recommends that the residence at 10 Maplewood Avenue, possibly constructed in the early 20th century and altered several times since its construction, does not contribute to the Cranbury Historic district. A secondary building, which has been identified as a historic fire station for Cranbury, contributes to the district.

The 2-story, gable-roofed, rectangular plan, main volume of this frame, painted clapboard-clad dwelling on a parged foundation is 2 bays wide and 3 bays deep. The main volume flanked on the northwest by a 1-story, hip-roofed, enclosed porch, and by a 1-story, shed and hip-roofed volume on the southeast. The roofline of the main volume changes pitch over an addition on the southwest where a second story was placed over an earlier porch. The roofs throughout are clad in asphalt shingle and the windows have 1/1 and horizontal 2/2 wood sash. The residence is accessed by an enclosed, recessed porch on the southwest, main elevation. An 8-light wood door flanked by 2, 8-light windows on the left and 1 on the right is located in the west bay. A double window lights the east bay, with a single window in each of the bays on the second floor. A single window lights the southwest elevation of each of the 1-story volumes. The southeast, side elevation is not visible from the public right-of-way. The northeast, rear elevation includes a single window in each of the outer bays of both floors of the main volume, with a single 6-light casement window in the rear volume. The northwest, street-facing elevation has a double window in each bay of the 1-story volume, a single, central window on the second floor beneath the gable, and a window in the south bay beneath the adjusted roofline.

This property is a non-contributing property in the historic district by virtue of multiple alterations after the end of the period of significance.
