PROPERTY REPORT

Property Name: 8 Maplewood Avenue **Ownership:** Private
Address: 8 MAPLEWOOD AVE **Apartment #:** **ZIP:** 08512

Survey Name: Cranbury Local Historic District Survey 2018

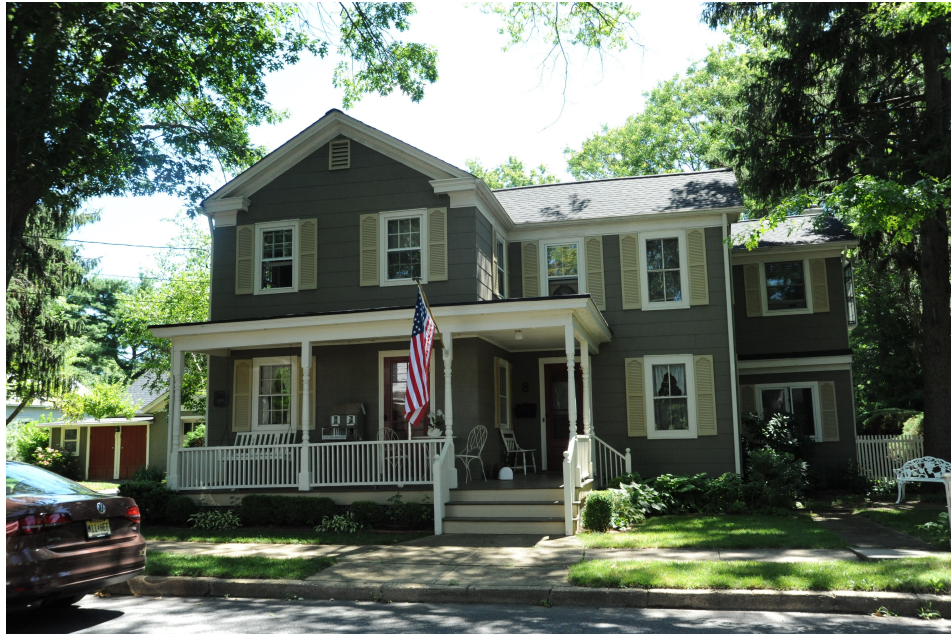
Property Photo:

The 2-story, gable-roofed, L-plan, asbestos shingle-clad, main volume of this frame residence on a parged foundation is 4 bays wide and 3 bays deep. A 1-story, hip-roofed porch on turned posts extends across the northwest, main elevation of the northwestern portion of the main volume and wraps around the southwest side to shelter a secondary entrance into the rear, southeastern portion of the main volume. A 2-story, gable-roofed addition projects from the southeast corner of the residence. The roofs are clad in asphalt shingle with eave returns at the gable-ends, and the windows predominantly have historic 6/6 wood sash and historic 2/2 wood sash with applied shutters. An interior brick chimney projects from the gable ridge of the northern portion of the main volume. The front porch is accessed by a straight stair and includes historic wood posts, a simple rail, and square-section balusters. The residence is accessed by 2 historic doors, with 1 in the south bay of the north volume and 1 in the north bay of the south volume. A window is in each of the remaining bays on each floor. A casement window lights the first floor of the rear volume and a 1/1 window lights the second floor. A pent eave divides the 2 floors. The south, side elevation includes a window on each floor of the main volume, a small, sliding window on the first floor of the rear volume, and a 1/1 window on the second floor. The east, rear elevation is not visible from the public right-of-way. The north, side elevation has a window in each bay of each floor except the central bay of the first floor.

This property is a contributing property in the historic district because it retains integrity and such character-defining historic features as the massing of its historic main volume, its historic front porch, historic chimneys, and historic window sash and wood doors.
