## PROPERTY REPORT

**Property Name:** 6 Maplewood Avenue **Ownership:** Private  
**Address:** 6 MAPLEWOOD AVE **Apartment #:** **ZIP:** 08512

**Survey Name:** Cranbury Local Historic District Survey 2018

## **Revisions from the Homeowner of 6 Maplewood Avenue**

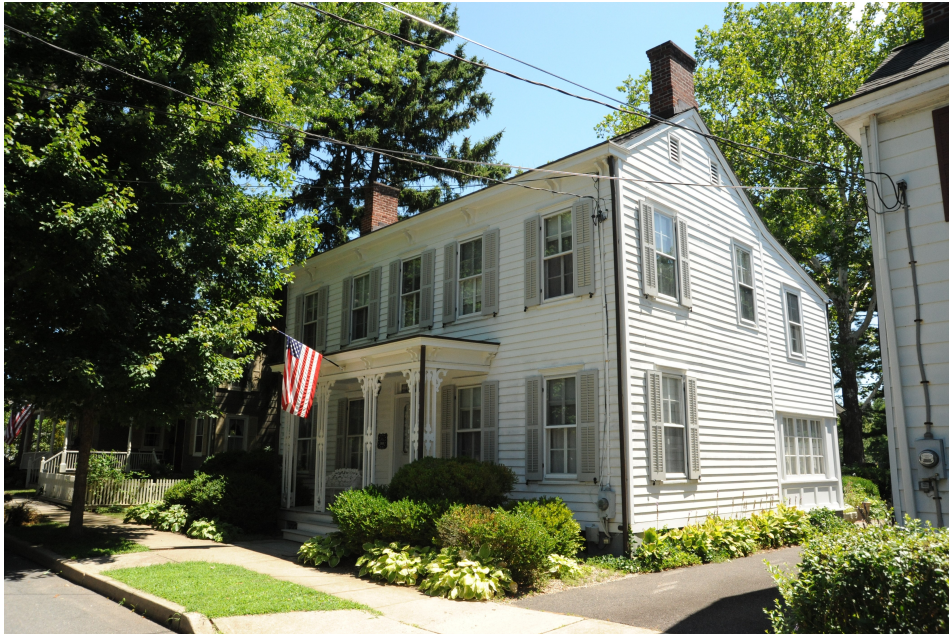
### Property Photo:

The 2-story, rectangular-plan, gable-roofed, clapboard-clad, main volume on a parged foundation of this frame dwelling is 5 bays wide and 2 bays deep and is fronted on the northwest by a 1-story, partial-width, composite-roofed porch and backed on the southeast by a 2-story, shed-roofed rear volume. The roofs are predominantly clad in asphalt shingle. The windows throughout contain 4/4 historic wood sash with thin horizontal muntins, and louvered wood shutters. Two interior brick chimneys project from the outer bays of the gable ridge. The front porch is accessed by a straight wood stair and includes historicized, jigsaw-cut posts and brackets, with additional, perpendicular brackets supporting the roof eave. The residence is accessed through a historic door, paneled door with extended octagonal toplights in the central bay of the main elevation. The door is topped by a historic, 2-light transom. Each of the remaining bays include a window on each floor. The southwest, side elevation includes a window in each bay except the east bay of the first floor. The rear volume includes a bank of replaced, 2/4-wood sash windows on the first floor and a single window on the second floor. The southeast, rear elevation is not visible from the public right-of-way. The northeast, side elevation includes a window on each floor of the west bay and a window on each floor of the rear volume. Both side elevations include 2 louvered vents under the gable peak.

The 1-story, gable-roofed, vertical board-sided garage is located to the southeast of the residence.

This property is a contributing property in the historic district because it retains integrity and such character-defining historic features as the massing of its historic main volume and front porch, historic chimneys, historic front door and door surround, and historic window sash and front door.
