PROPERTY REPORT

Property Name: 30 Maplewood Avenue **Ownership:** Private
Address: 30 MAPLEWOOD AVE **Apartment #:** **ZIP:** 08512

Survey Name: Cranbury Local Historic District Survey 2018

Organization: Paulus, Sokolowski & Sartor

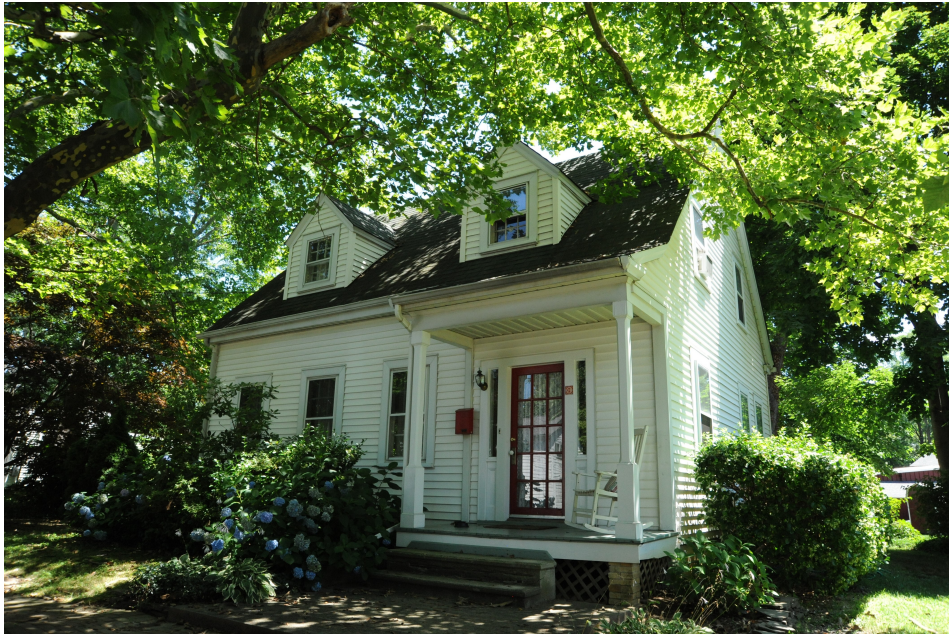
Property Photo:

The 1 ½-story, gable-roofed, rectangular plan, vinyl siding-clad, main block of this frame dwelling on a concrete foundation is 4 bays wide and 3 bays deep and is fronted on the northwest by a 1-story, shed-roofed front porch and backed on the southeast by a 1-story, partial-width, centered, shed-roofed el. The roofs are clad in asphalt shingle and the windows have 6/6, double-hung, historic wood sash. The roof includes an interior stuccoed chimney in the central bay of the gable ridge and a shed-roofed dormer in the central bay of the southeast slope. The front porch is 1 bay wide in the southwest corner of the main elevation and includes replaced posts. The replaced, 16-light door in the primary entrance of the residence is accessed by the porch and includes a historic door surround with historic, single-light sidelights. The southwest, side elevation is lighted by a window in each bay of the first floor, with 2 windows on the second floor. The southeast, rear elevation is not visible from the public right-of-way. The northeast, side elevation is lighted by a window in the outer bays of the first floor and 2 windows on the second floor.

A 1-story, gable-roofed, frame garage, not visible from the public right-of-way, is located to the southeast of the residence.
