PROPERTY REPORT

Property Name: 54 Maplewood Avenue **Ownership:** Private
Address: 54 MAPLEWOOD AVE **Apartment #:** **ZIP:** 08512

PS&S recommends that 54 Maplewood Avenue, constructed in the 1930s, is a contributing property in the Cranbury Historic District.

Survey Name: Cranbury Local Historic District Survey 2018

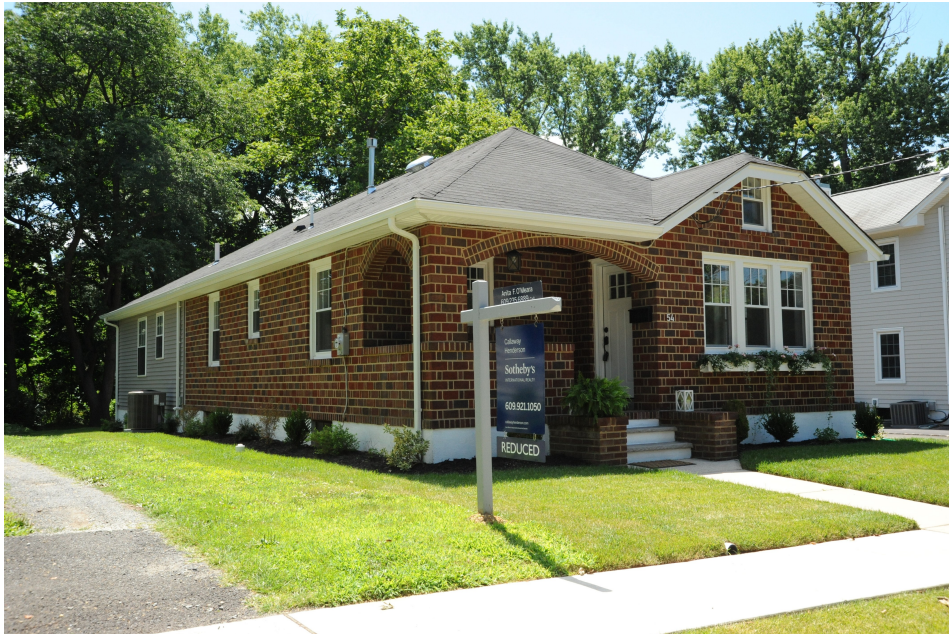
Property Photo:

The 1-story, hip-roofed, rectangular plan, Flemish bond brick bungalow on a parged foundation is 2 bays wide and 3 bays deep and is fronted by a 1-story, jerkinhead-roofed entry volume and a recessed porch. A 1-story frame addition backs the main volume on the southeast. The roofs throughout are clad in asphalt shingle and the windows throughout have 6/1 replacement vinyl sash with applied muntins. The recessed porch, located in the northeastern bay of the northwest, main elevation, includes a brick knee wall, segmental arch openings, and a historic, varnished wood ceiling. The primary entrance to the residence is located in the northwest side bay of the entry volume and includes a replaced 6-light door. A single window lights the remaining bay, with a triple window and a window under the jerkinhead lighting the entry volume. The southwest, side elevation is lighted by a single window in the northwest bay and a double window in each of the remaining bays. The rear volume is accessed by a secondary door with a straight stair in the central bay and is lighted by a single window in the southeast bay and a double window in the northwest bay. The southeast, rear elevation is not visible from the public right-of-way. The northeast, side elevation is regularly fenestrated with a window in each bay.

This property is a contributing property in the historic district because it retains integrity and historic character-defining features such as its historic massing and fenestration patterns, historic brick exterior, and historic open front porch.
