PROPERTY REPORT

Property Name: 29 South Main Street **Ownership:** Private
Address: 29 S MAIN ST **Apartment #:** **ZIP:** 08512

Survey Name: Cranbury Local Historic District Survey 2018

Organization: Paulus, Sokolowski & Sartor

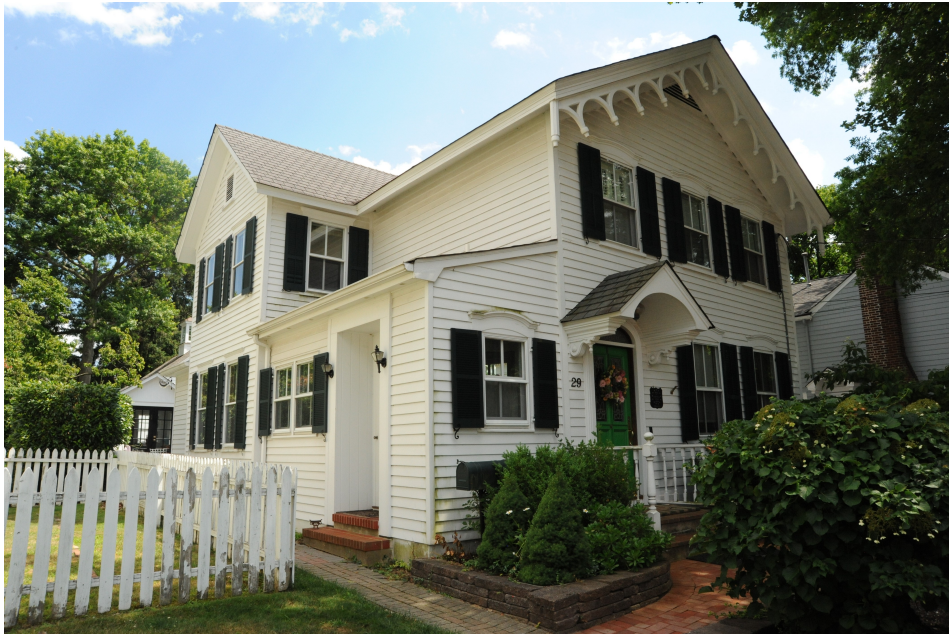
Property Photo:

The 2-story, gable-roofed, L-plan main block of this clapboard-clad dwelling on a parged stone foundation is 3 bays wide and 3 bays deep and is backed on the southeast by a 2-story, cross-gable-roofed rear volume that projects beyond the northwest elevation of the main volume. A 1-story, hip-roofed porch, added in 2016, backs the rear volume. A 1-story, shed-roofed, enclosed porch volume flanks the northeast side of the main volume. An added gabled door hood with a segmental arch opening and pendant brackets is located in the northeast bay of the northwest, main elevation. The roofs are predominantly clad in asphalt shingle and the windows predominantly have 2/2 replacement wood sash. An interior brick chimney projects from the central bay of the southwest roof slope. The primary entrance, located in the northeast bay of the northwest, main elevation, includes a 2-light, leaded glass, replaced door with replaced, segmental arch, leaded glass transom and a replaced rail with replaced newels. The remaining bays of both floors are regularly fenestrated and include historic shutters and eyebrow arch entablatures. A single window lights the enclosed porch volume. The southwest, side elevation is regularly fenestrated in both the main and rear volumes. The northeast, side elevation is regularly fenestrated and includes a secondary, recessed opening in the northwest bay of the enclosed porch. The southeast, rear elevation is not visible from the public right-of-way. The 1-story, gable-roofed, frame outbuilding, located to the southeast of the residence, is accessed on the northwest and southeast elevations

by added French doors and on the southwest elevation by a historic, 6-light door with a flanking historic window. The 1 1/2-story, gable-roofed, frame garage, located to the southeast of the outbuilding, is 2-bays wide and is lighted by 6/6 sash windows. A cupola with fixed 9-light windows is in the central bay of the gable ridge.
