PROPERTY REPORT

Property Name: 35 South Main Street

PS&S recommends that 35 S. Main Street, built circa 1820, is a contributing property in the Cranbury Historic District.

Survey Name: Cranbury Local Historic District Survey 2018

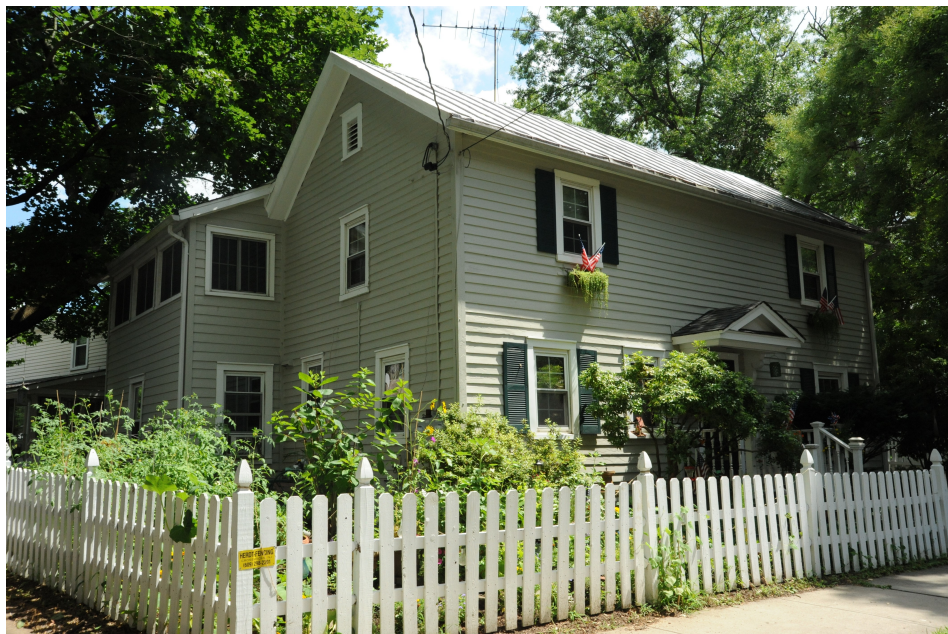
Property Photo:

The main block of this 2-story, side gable-roofed, rectangular-plan main block of this clapboard-clad, frame dwelling on a stone foundation is 4 bays wide and 2 bays deep and is backed on the southeast by a 2-story, cross gable-roofed, partial-width secondary volume offset to the northeast that projects beyond the northeast elevation and a 1-story, gable-roofed, attached garage to the southwest that projects beyond the southwest elevation of the main volume. A recessed porch is located in the southwest corner of the rear volume. The main volume roof is clad in standing seam metal. The rear volume and garage roof are clad in asphalt shingle and the windows throughout have 4/4 replaced sash with applied muntins and applied shutters. The primary entrance to the residence, located in the center of the northwest elevation and marked by a pedimented hood, is accessed by a stair with a replaced rail and replaced turned balusters and includes a replaced 8-light door and historic pedimented door hood with shaped brackets. The southwest bay is fenestrated on the first floor by a replaced 6/6 sash window and on the second floor by an offset 4/4 window. The northeast bay is lighted by 2 single windows on the first floor and an offset single window on the second floor. The southwest, side elevation is asymmetrically fenestrated with offset 6/6 windows on both floors of the northwest bay and a single 4/4 window on the first floor of the southeast bay. The second floor of the rear volume is regularly fenestrated on the southwest side. The garage is accessed by a roll-up door on the southwest elevation. An entrance on the southwest elevation of the rear volume is accessed by the recessed porch, which includes a square-plan post with beveled edges. The

northeast, side elevation of the main block is lighted by 2 windows on the first floor and a single window on the second floor. The rear volume is lighted by a single window on the first floor and a double window on the second floor of the northwest elevation and by a single window and 3 double windows on the northeast elevation. The southeast, rear elevation is asymmetrically fenestrated.

South Main Street includes some of the earliest development in Cranbury. The settlement began in 1736 with the construction of a mill on the south banks of the Cranbury Brook and, by 1810, developed into a small village. The 1980 National Register of Historic Places Nomination for the Cranbury Historic District indicates that the 2-story, frame residence with a center entrance at 35 S. Main Street was built in the mid-19th century. The 1989 Heritage Studies Inventory reports that a plaque on the residence dates it to 1820, but that the small windows on the north end of the main elevation suggest an earlier construction date for part of the dwelling. Historic maps indicate that a residence owned by "N. Rue" was built on the property by 1876. A historic photograph taken circa 1890 depicts the building as the Rue residence and bootmaker's shop. The clapboard clad building is fronted by a full-length, composite-roofed porch with square-plan posts, and is lighted by 6/6 windows. In the southwest bay is a projecting, 12-light display window and a 4-light door. This evidence suggests that the bootmaker's shop was located in the southwest bays of the building and the residence located in the northeast bays (Brennan and Brennan, 1995: 19). The 1916 Sanborn Map documents the building as a 2-story, rectangular-plan, frame dwelling fronted by a 1-story, partial-width porch and backed by a 1-story, partial-width rear volume with a projecting bay. A 2-story secondary dwelling, now 3 Station Road, is also documented as part of the lot. The 1933 Sanborn Map documents the same massing of the dwelling. The 1974 photographic inventory of Cranbury historic buildings in the collection of the Cranbury Historical and Preservation indicates that the front porch was replaced by a pedimented door hood with shaped brackets sometime in the mid-20th century. This image also documents the residence as having a 3-light door, 6/6 sash windows, and a standing seam metal roof. Visual evidence suggests that the door, window sash, and roofs have been replaced within the last ten years.

This is a contributing property in the Cranbury Historic District because it retains integrity and historic, character-defining features such as the historic massing and historic fenestration patterns of the main volume.
