PROPERTY REPORT

Property Name: 11 South Main Street **Ownership:** Private
Address: 11 S MAIN ST **Apartment #:** **ZIP:** 08512

Survey Name: Cranbury Local Historic District Survey 2018

Organization: Paulus, Sokolowski & Sartor

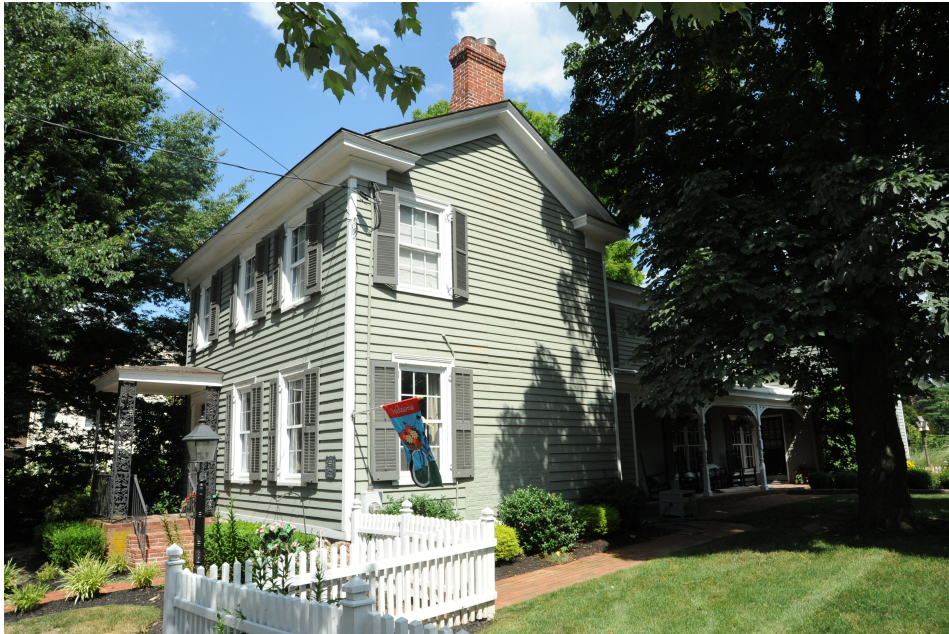
Property Photo:

The 2-story, side gable-roofed, rectangular-plan main block of this clapboard-clad, frame dwelling on a stone foundation is 3 bays wide and 2 bays deep and is fronted on the northwest elevation by a 1-story, hip-roofed, partial-width porch offset to the northeast, and backed on the southeast elevation by a 2-story, gable-roofed volume. The rear volume is in turn backed by a 2-story, cross gable-roofed addition. A 1-story, shed-roofed porch flanks the southwest elevation of the rear volume, and a 1-story, composite-roofed, 3-sided window bay is on the northwest bay of the northeast elevation of the rear volume. A 1-story, shed-roofed, enclosed porch backs the northeast bay of the rear volume. The roofs are predominantly clad in asphalt shingle with eave returns at the gable-ends and the windows predominantly have 6/6 replacement vinyl sash with applied muntins and historic louvered wood shutters. A substantial, replaced, interior brick chimney projects from the west bay of the gable ridge. A second substantial, exterior brick chimney projects from the northeast elevation of the rear volume. The primary entrance with historic replacement door and historic door surround is located in the northeast bay of the northwest elevation and is accessed by the front porch, which includes a brick stair, cast iron posts, and a wrought-iron rail. The remaining bays of both floors are regularly fenestrated. The southwest, side elevation is lighted in the main volume by a window on each floor of the northwest bay. The painted brick chimney base is exposed in the lower portion of the first floor of the central bay. The rear volume, only partially visible from the public right-of-way, is lighted by double windows on the first floor and single windows on the second floor and includes a secondary

entrance. The rear porch includes historic turned posts and historic wood brackets. The rear volume is not visible from the public right-of-way. The northeast, side elevation is lighted 2 windows on the first floor of the main volume, 3 windows in the projecting bay of the rear volume, and 2 windows on the second floor of the rear volume.

The residence at 11 S. Main Street is a contributing property in the Cranbury Historic District because it retains integrity and historic, character-defining features such as its historic massing of the main volume, historic wood shutters, historic rear porch posts, and historic eave returns.
