## PROPERTY REPORT

**Property Name:** 52 South Main Street **Ownership:** Private  
**Address:** 52 S MAIN ST **Apartment #:** **ZIP:** 08512

PS&S recommends that 52 Main Street, which includes a residence and garage constructed circa 1920, is a contributing property in the Cranbury Historic District.

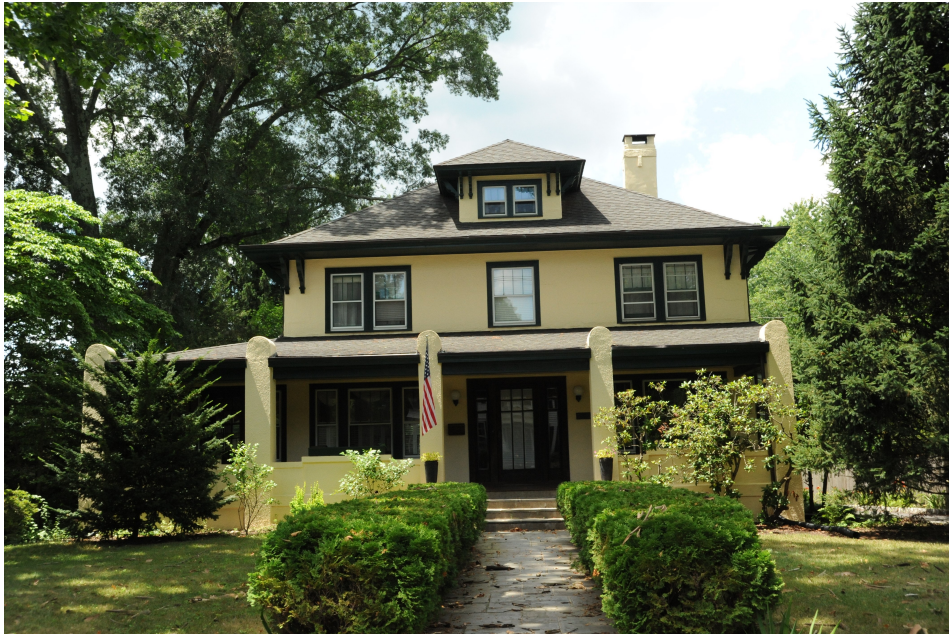
### Property Photo:

The 2 ½-story, hip-roofed, foursquare main block of this stuccoed, Craftsman-style dwelling on a stucco foundation is 3 bays wide and 2 bays deep and is fronted on the southeast by a hip-roofed, full-width porch that extends to the southwest to front a 1-story, hip-roofed, partial-width side volume, and backed on the northwest by a 1-story rear el offset to the northeast. A 1-story, hip-roofed, 3-sided bay projects from the southeast bay of the northeast elevation. A hip-roofed dormer projects from the southeast roof slope. An interior, stuccoed chimney is located near the center of the northeast, main roof slope. The roofs throughout are clad in asphalt shingle and have paired, shaped eave brackets along the cornice of the main block and the front dormer. The windows predominantly have 3/1 and 4/1 historic wood sash. The front porch, accessed by a stair in the central bay, includes a stuccoed knee wall with a raised central panel in each bay and stuccoed pillars with round-arched caps that project beyond the roofline. The primary, centered entrance includes a historic door with 6 small lights over 3 extended single lights and historic sidelights with 2 lights over 1 extended light. Both of the outer bays are lighted by a single 4/1 window flanked on either side by 2/1 windows. The second floor is lighted by a single 4/1 window in the central bay and paired 3/1 windows in the outer bays. A paired, smaller 3/1 window lights the dormer. The northeast, side elevation is regularly fenestrated and includes a triple window in the northwest bay of the first floor and a single window lighting the el. The southwest, side

elevation, only partially visible from the public right-of-way, is regularly fenestrated. The northwest, rear elevation is not visible from the public right-of-way. The 2 bay, side gable-roofed garage, located to the northwest of the residence, includes historic paired 3-light doors.

The residence at 52 S. Main Street contributes to the Cranbury Historic District because it retains integrity and historic, character-defining features such as its historic massing, historic windows, historic door and door surround, historic porch pillars and knee walls, historic eave brackets, historic chimney, and historic surface cladding. The matching garage it retains its historic doors.
