PROPERTY REPORT

Property Name: 9 Prospect Street **Ownership:** Private
Address: 9 Prospect ST **Apartment #:** **ZIP:** 08512

Survey Name: Cranbury CLG Survey 2017

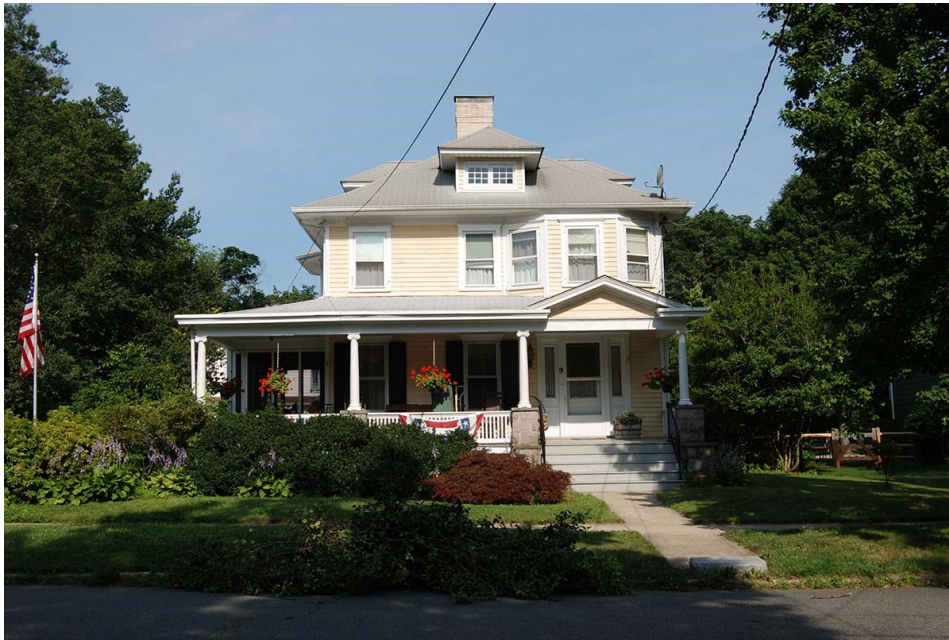
Property Photo:

9 Prospect Street is a two-and-a-half-story tall, four-bay wide, three-bay deep, frame private residence constructed circa 1911 in a vernacular interpretation of the American Foursquare form. The dwelling consists of a square main block, a one-story, three-bay addition (built circa 1978) extending to the northwest, and a partially enclosed wraparound porch. The dwelling has a cast stone (concrete block) foundation. The deeply hipped roof (nearly pyramidal) is sheathed with asphalt shingles. A central brick chimney pierces the dwelling at the ridgeline. Hipped dormers with widely overhanging eaves sit on the front (southeast), northeast, and southwest bents of the roof. The dormers have paired, fixed, potentially original wood windows with nine inset lights. The exterior of the dwelling is clad in aluminum siding. Windows on the front elevation are one-over-one, double-hung, wood-sash windows with molded wood lintels. On the second floor, the semi-hexagonal north bay projects from the front of the dwelling. Windows on the first floor have inoperable louvered shutters. The entrance, located in the northeast corner of the dwelling (below the second floor projecting bay), consists of a one-light, two-panel wood door with sidelights. The door is inset within a molded wood surround featuring molded panels below the sidelights. The first floor is sheltered by a wraparound porch that features a slightly flared hipped roof with an inset gable over the entrance; it is partially enclosed on the dwelling's southwest elevation. The porch eaves are supported by four thin Ionic columns standing on stone piers connected by a low railing. A wide set of frame steps leads down to the grade of the front lawn. Windows on the northeast elevation, clad in aluminum siding, are one-over-one, double-hung, wood-sash windows with molded wood lintels. The rear elevation is not visible from the public right-of-way. On the southwest elevation, clad in aluminum siding, the west bay is a semi-hexagonal projecting bay similar to the projecting bay on the

front elevation. Windows on the southwest elevation are one-over-one, double-hung, wood-sash windows with molded wood lintels. The enclosed portion of the wraparound porch has fixed vinyl screen windows. Character-defining elements of the dwelling include hipped dormers, semi-hexagonal projecting bays, and a one-story wraparound porch with rusticated stone piers and Ionic columns.
