## PROPERTY REPORT

**Property Name:** 83 North Main Street  
**Address:** 83 N Main ST

**Survey Name:** Cranbury CLG Survey 2017

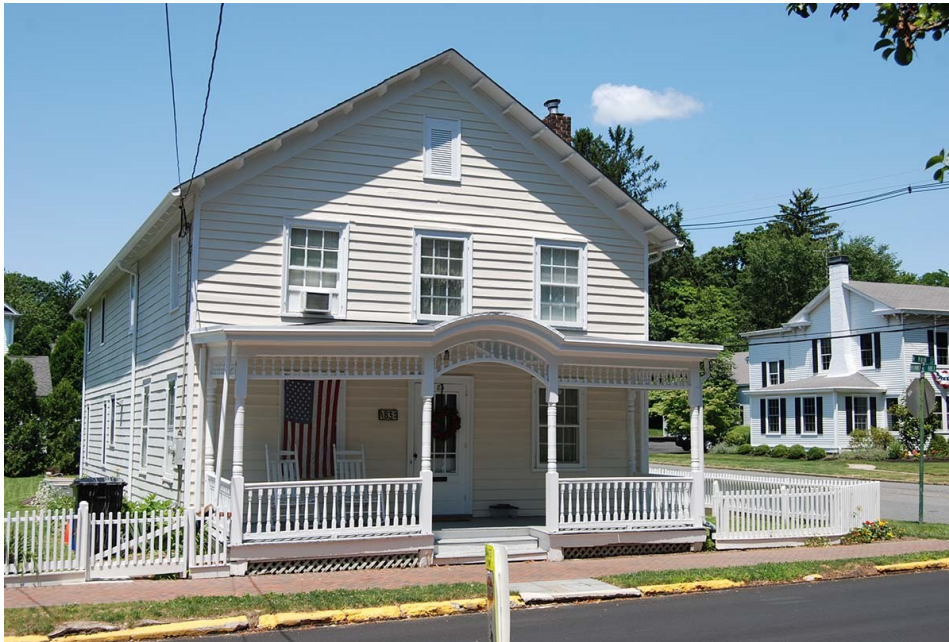
### Property Photo:

83 North Main Street is a two-story tall, three-bay wide, three-bay deep, frame private residence constructed circa 1860 in a vernacular style with a Queen Anne style front porch. The dwelling consists of a rectangular, front-gabled main block, a two-story, three-bay rear addition, and a one-story, three-bay shed roof addition (both constructed circa 2000) to the rear. The roof is sheathed with asphalt shingles with overhanging eaves and exposed rafters. A capped, interior brick chimney pierces the roof on the northeast bent of the main block. The exterior of the dwelling is clad in wood clapboard siding on the front elevation and vinyl siding on the side elevations. A louvered window sits in the front gable end. Windows on the front elevation are six-over-six, double-hung, replacement wood-sash windows on the first and second floors. The central historic entrance is a two-panel wood door with a one-panel, wood screen door. The first floor is sheltered by a one-story, full-length porch with a hipped roof that is arched in the center. The porch has a frieze of spindles below the eaves and four turned posts connected by a low railing with thin turned balusters. Regular, symmetrical fenestration on the northeast elevation consists of six-over-six replacement wood-sash windows on the first and second floors. A recessed secondary entrance, a four-panel wood door with an aluminum storm door, is located in the east bay. The southwest elevation has six-over-six, double-hung, replacement wood-sash windows, arranged asymmetrically, on the first and second floors. Character-defining elements of the dwelling include the louvered gable end window, exposed rafters, and porch with spindlework details. A one-story, front-gabled garage (constructed circa 1960) is located west of the dwelling.
