PROPERTY REPORT

Property Name: Aaron Lane House **Ownership:** Private
Address: 73 N Main ST **Apartment #:** **ZIP:** 08512

Survey Name: Cranbury CLG Survey 2017

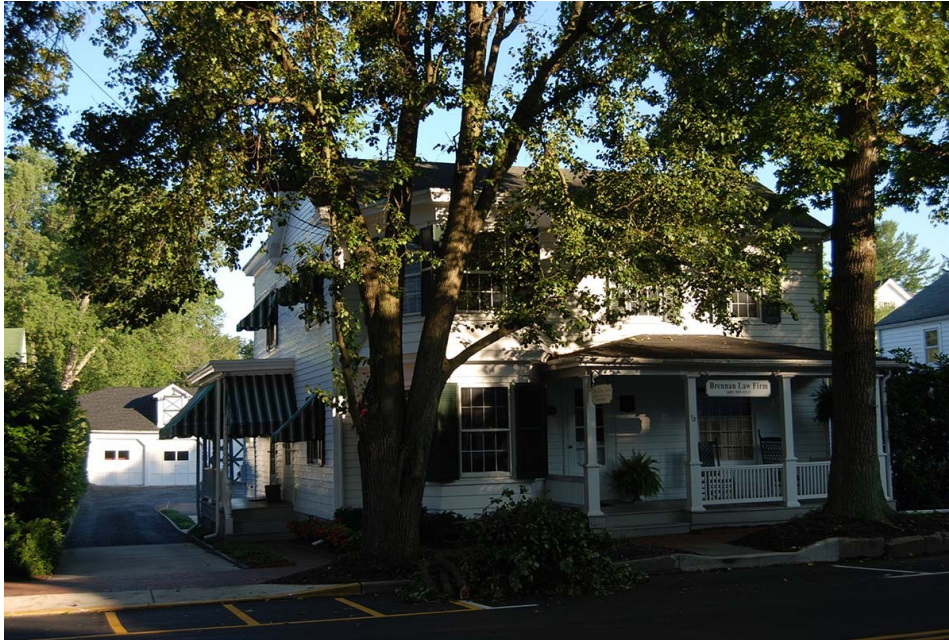
Property Photo:

The Aaron Lane House at 73 North Main Street is a two-story, three-bay, two-pile, frame commercial building constructed circa 1850 and renovated circa 1880 in a vernacular Queen Anne style when a bay window was added on the main elevation. It has a two-story rear addition and a garage in the rear of the property.

The house has a side-gabled roof sheathed with asphalt shingles and featuring an interior rectangular brick chimney at each end of the ridge. The molded cornice includes returns on the end walls. The exterior of the frame building is clad in wood clapboard siding. Fenestration consists primarily of six-over-six, double-hung, wood-sash windows with louvered shutters. The hexagonal bay aligned with the south wall features eight-over-eight, double-hung, wood-sash windows with louvered shutters on each of its three panels on each floor. The front porch occupies the first floor north of the bay; its hipped roof is clad with asphalt shingles and features a frieze, four square columns attached by a railing with square balusters, and a wood floor. The entrance is a wood door with twelve inset lights over one panel, opening south of a large picture window with multiple inset lights. The house has a stone foundation.
