PROPERTY REPORT

Property Name: 37 North Main Street **Ownership:** Private
Address: 37 N Main ST **Apartment #:** **ZIP:** 08512

Survey Name: Cranbury CLG Survey 2017

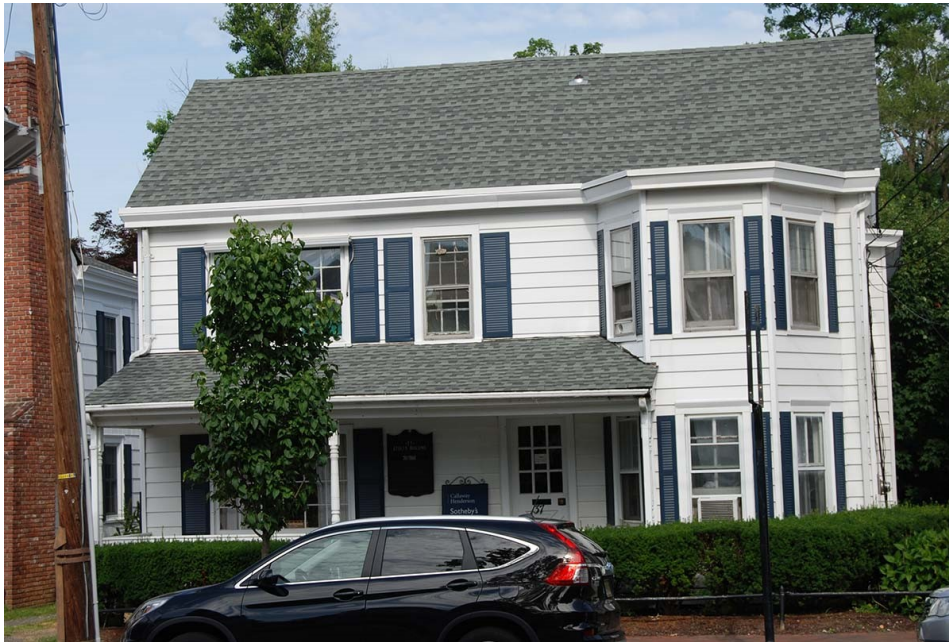
Property Photo:

37 North Main Street is a two-story tall, three-bay wide, two-bay deep, frame commercial building constructed circa 1878. The building, a converted private residence that sits on a concrete foundation, consists of a rectangular, side-gabled main block; a two-story, L-shaped rear addition (built circa 1960); and a one-story shed roof rear addition (built circa 1960). The roof is sheathed with asphalt shingles. An exterior brick chimney is located in the northwest corner. The exterior of the building is clad in aluminum siding on all elevations. A two-story, semi-hexagonal projecting bay is located in the north bay on the front elevation. This projecting bay has two-over-two, double-hung, replacement wood-sash windows on the first and second floors with narrow, inoperable louvered shutters. On the main block, the central bay has a six-over-six, double-hung, wood-sash window (potentially original) with inoperable louvered shutters. On the first and second floors in the south bay, there are twenty-four light fixed replacement wood windows with inoperable louvered shutters. The southern bays on the first floor are sheltered by a shed roof porch with turned wood posts and a wood balustrade. The central entrance is a single-leaf door with nine inset lights over a crossbuck. The northeast elevation has two louvered windows in the gable end of the main block and two-over-two, double-hung, wood-sash windows on the first and second floors. The rear elevation is not visible from the public right-of-way. The southeast elevation also has two louvered windows in the gable end of the main block with two-over-two, double-hung, wood-sash windows on the first and second floors. The semi-hexagonal projecting bay on the front elevation is a character-defining feature of the subject building.
