## PROPERTY REPORT

**Property Name:** Samuel Disbrow, Jr. House      **Ownership:** Private  
**Address:** 13 N Main ST      **Apartment #:**      **ZIP:** 08512

**Survey Name:** Cranbury CLG Survey 2017

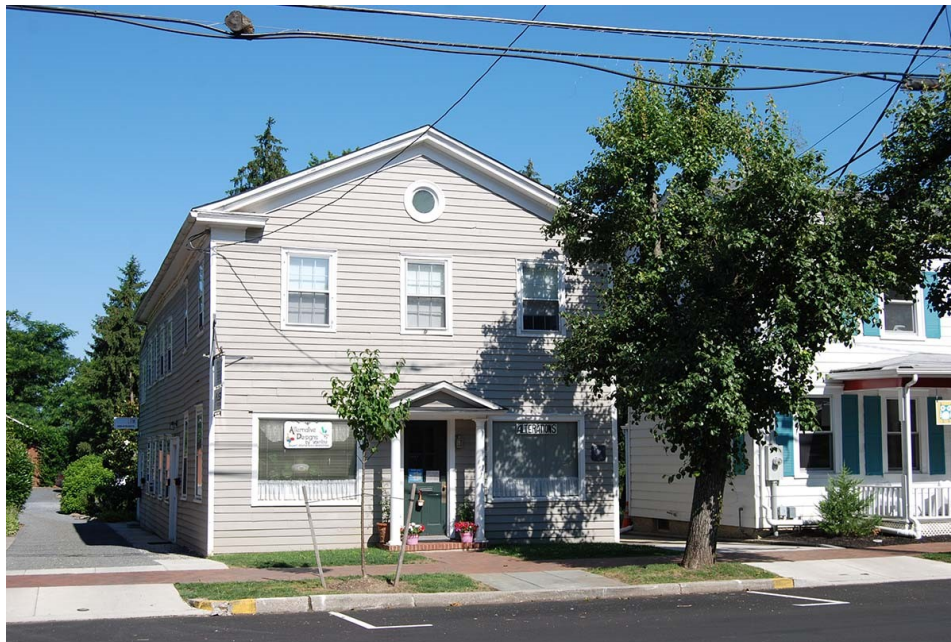
**Property Photo:**

The Samuel Disbrow, Jr. House at 13 North Main Street is a two-story tall, three-bay wide, six-bay deep, frame commercial building constructed in 1810 with Greek Revival details. The building consists of a rectangular, front-gabled main block and a two-story, two-bay wide rear addition (constructed before 1916). The roof is sheathed with asphalt shingles and features a molded wood cornice with a return cornice at the front gable end. The exterior of the building is clad in wood clapboard siding on all elevations. On the front elevation, a wood ocular window (dating to the 1850s) sits in the gable end. Three six-over-six, double-hung, wood-sash windows (likely original) are located on the second floor, spaced evenly across the façade. The first floor has two large picture windows (replacement) on either side of the entrance, a single door with four inset lights above two rectangular panels. A pediment-front entry porch with unfluted Doric columns shelters the entrance. Access is gained via a brick stoop. The north elevation features a wood frieze beneath the slightly overhanging eaves. Windows on the north elevation of the main block and rear addition are six-over-six, double-hung wood-sash (likely original) with molded wood lintels. A wood frieze runs beneath the overhanging eaves on the south elevation. Windows on the south elevation of the main block and rear addition are six-over-six, double-hung, wood-sash windows with molded wood lintels. Two secondary entrances, single doors with four inset lights above two rectangular panels, are located in the east-center bay on the main block and in the west bay on the rear addition. The rear elevation is not visible from the public right-of-way. The foundation is not visible beneath the wood clapboard siding. Character-defining elements of the building include the wood ocular window in the front gable end, the molded wood return cornice, and wood-sash windows.
